**BISHOPWEARMOUTH:**  
*A HISTORICAL VILLAGE ATLAS*  
*Part 2: Supplementary Reports*

Produced by  
The Archaeological Practice Ltd & the Bishopwearmouth Village Atlas Group

NOS. 1-2 CHURCH LANE AND  
314-315 HIGH STREET  
BISHOPWEARMOUTH  
SUNDERLAND

HISTORIC BUILDING RECORD

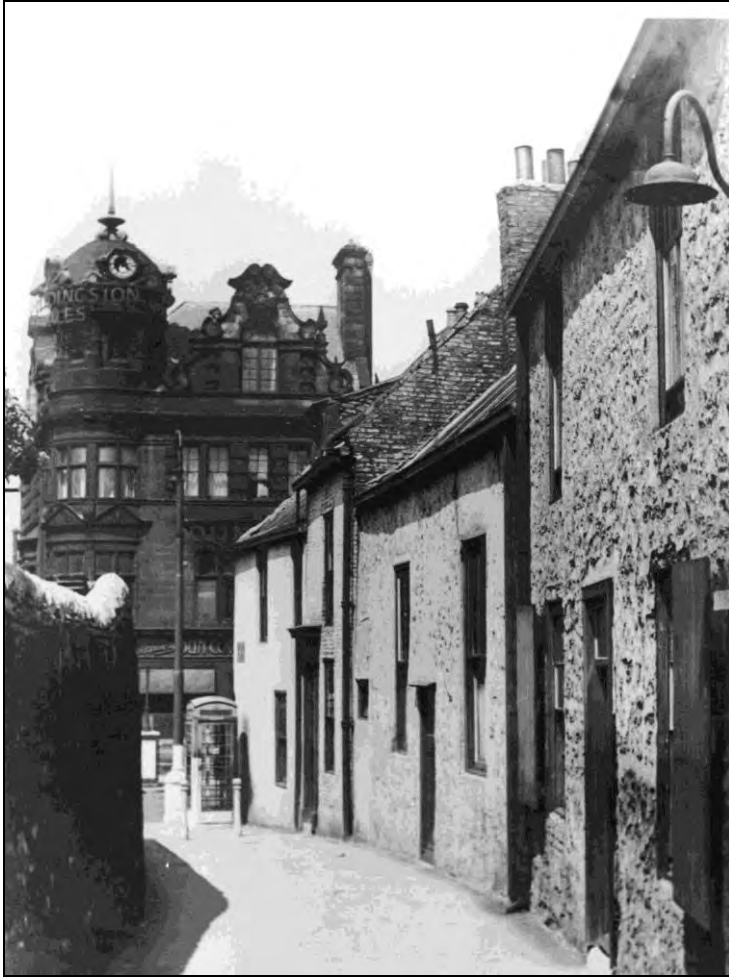
*Illus. 07:  
The west side of the buildings on Church Lane prior to alterations in the 1970s.*

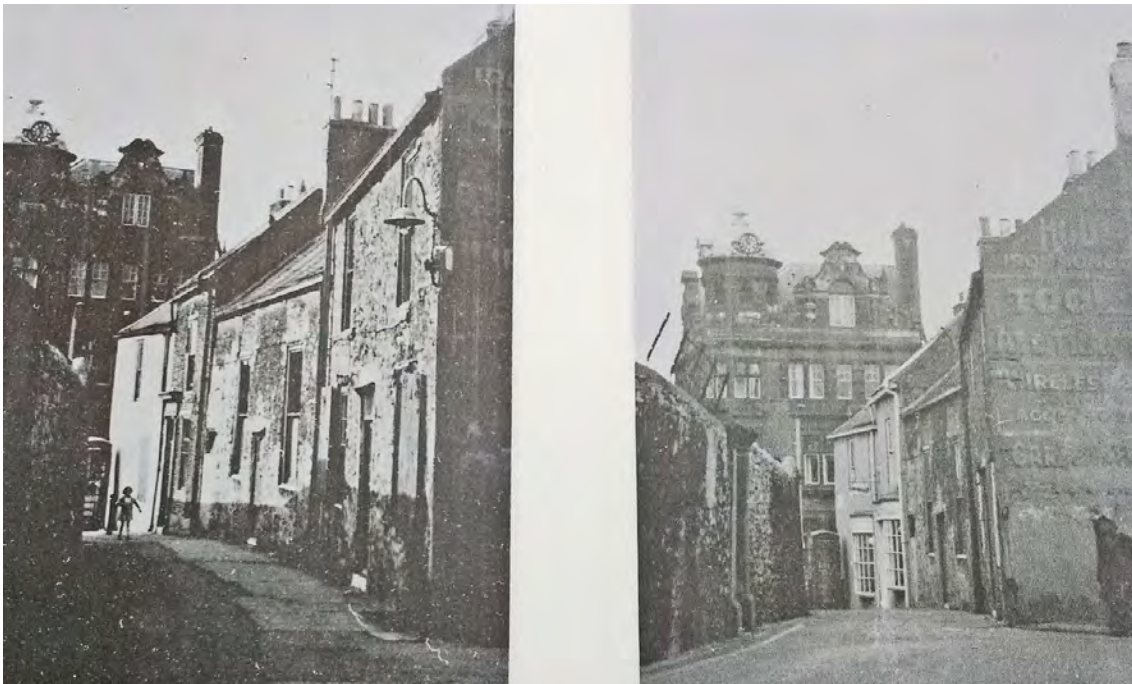
*Illus. 08i & ii: The west side of the buildings on Church Lane before and after alterations in the 1970s.*

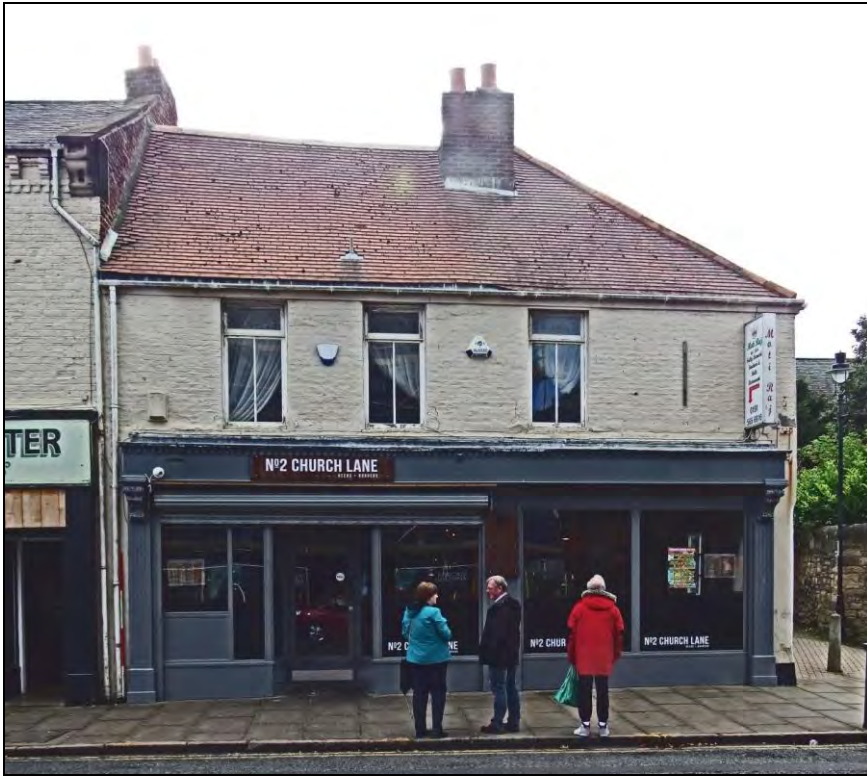
*Illus. 09: North Elevation (to High Street West)*

The north elevation, to High Street West, is the north wall of the Northern Building. The ground floor is all modern, a pair of shop fronts flanking a recessed doorway on the left and a pair of windows on the right, between fluted pilasters, with carved brackets carrying a fascia with a block cornice. The first floor is of old brick<sup>1</sup>, yellow-washed<sup>1</sup> with three irregularly-spaced windows, of quite tall and narrower proportions, each now holding a 20th-century top-opening casement with a pair of upright panes below. The roof has a stack, set east-west, of old brown brick at the west end of the ridge.

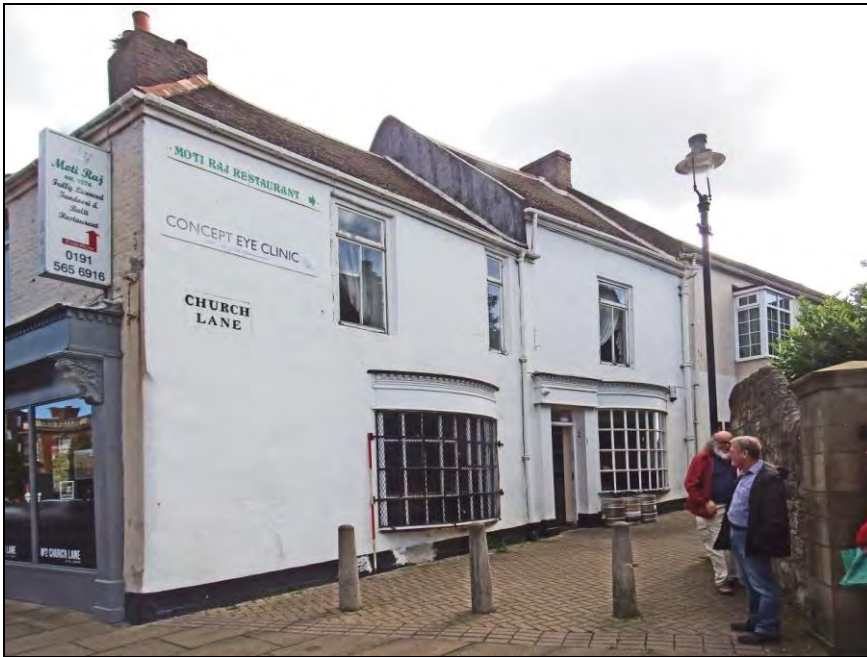
*Illus. 10: North-West Elevation, to Church Lane*

The west elevation, to Church Lane, is rendered and whitewashed, and is in two parts. On the left is the Northern Building, with a recent bow window on the ground floor and two first-floor windows, one like those on the north, and the other, to the right, in a narrower opening. To the right is the slightly taller Southern Building, with a modern doorway (with fluted pilasters) on the ground floor and another bow window set close to it on the south, and a single first floor window like the three on the north. The roof has a northward-facing gable with a thin raised coping.

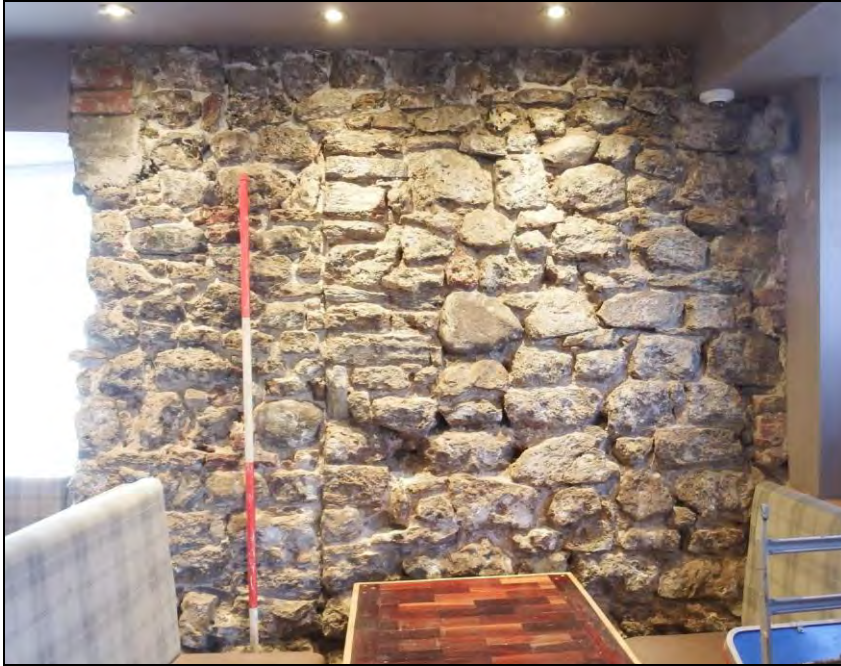
*Illus. 11 (above): Wall B, northern section*

The west wall of the ground floor of the Northern Building, broken by a wide 20th-century window. The south internal jamb of the window is in modern brick, with what looks like a cutaway concrete block immediately below the present lintel. Between this and the south wall of the building (wall E) is roughly-coursed limestone rubble; wall E is of brick except for two or three courses of limestone at the bottom; this may be contemporary with wall B, but above this the brickwork seems to extend behind the stone of wall B. The north internal jamb of the window is cut into old stone walling. In the wall c 0.75 m to the north there is a straight joint; beyond this is rather better-quality walling with some large blocks of Ryhope limestone; some roughly-squared blocks abut against the straight joint in quoin-like fashion possibly implying that the northern section is earlier.<sup>2</sup>

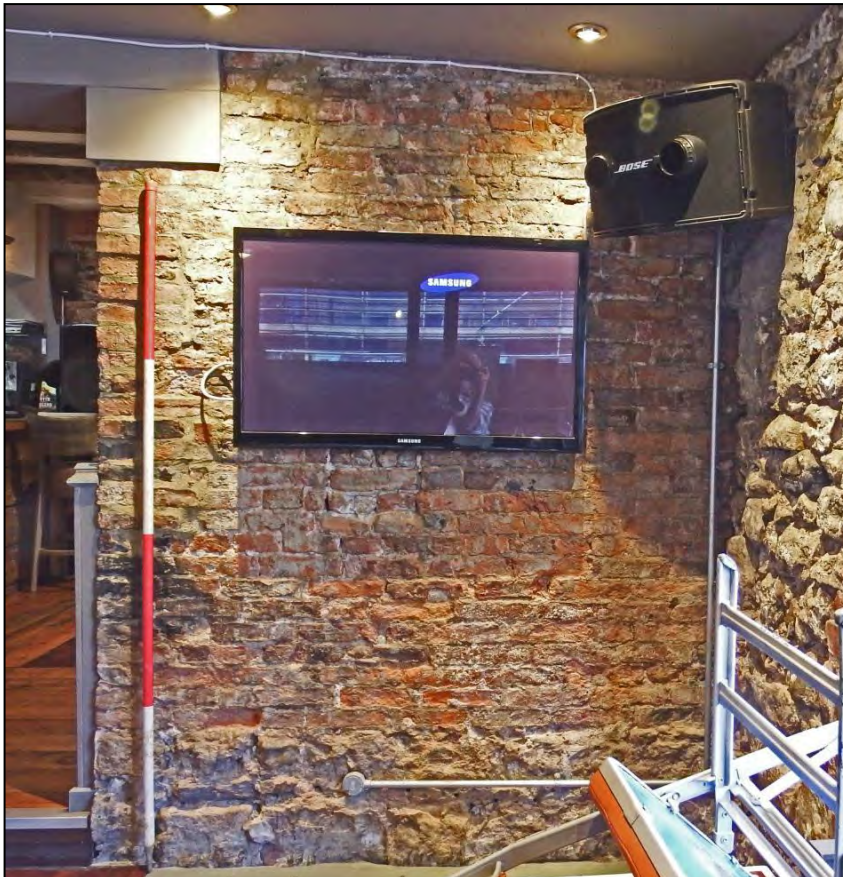
*Illus. 12 (below): Wall C, western section*

This is the south wall of the northern building (i.e. the cross wall between the two buildings) and a large part of it was cut away during the recent alterations. A length of undisturbed wall survives at the west end, with a few courses of large limestone blocks up to c 0.60 m, and above that old brick, largely in stretcher bond (which at its west end seems to extend behind the limestone rubble of wall B); midway along it is an infilled recess, c 1.2 m above the floor, c 0.30 m wide and 0.20 m high.

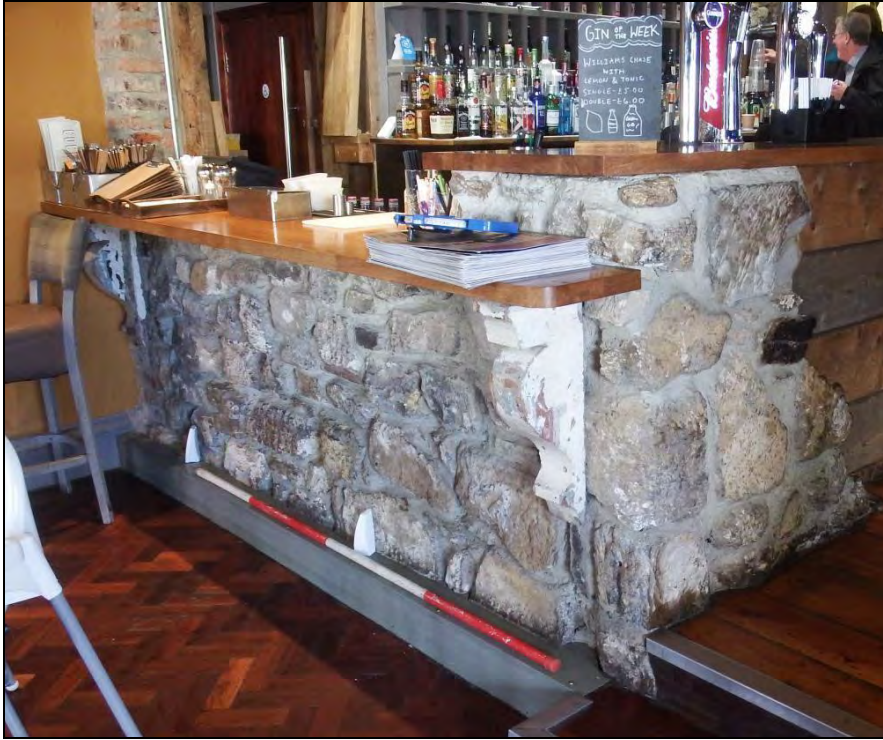
*Illus. 13: Eastern section of Wall C, now forming base of bar*

The lower part of the eastern section of the wall, of large limestone rubble, survives as the base of the bar.

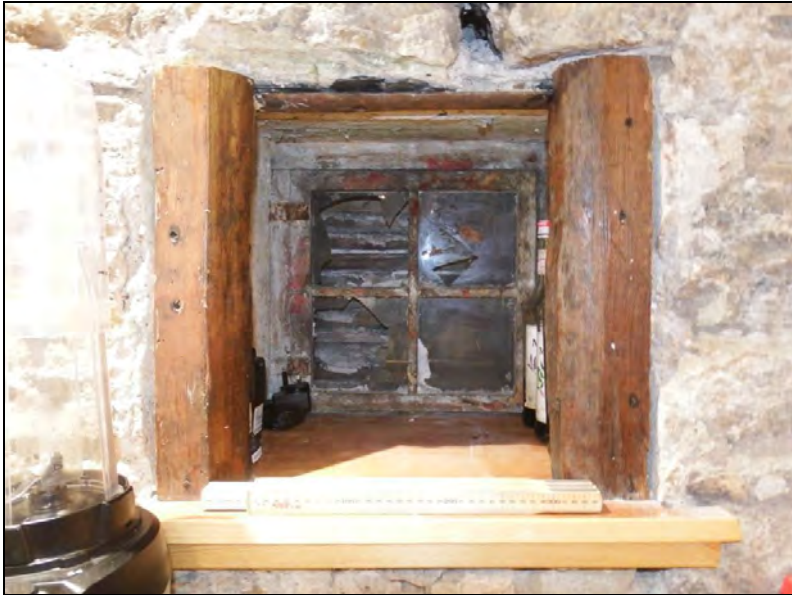
*Illus. 14: Small window at south end of wall D*

This thinner end section is rendered and plastered (on its east face old brown brick is exposed, but contains one window, cut across by the present ceiling, which is a 6-pane casement, with below it a rectangular ashlar block with the incised date '1854') At the north end of the principal thicker section of wall is an east-west ceiling beam marking the line of the wall dividing the two buildings, only recently removed. Beyond this is a doorway and a length of wall hidden by modern fittings, then finally a panel of exposed walling c 1.5 m long, containing a small almost square window set quite low down. Its internal opening has a thin timber lintel, and a wooden post at either side that look to be re-used pieces, and may be contemporary with the modern wooden sill; the window itself, in line with the east face of the wall (and now opening within the rear block) is a 4-pane opening casement, hung on old hinges that appear of 18th-century character.

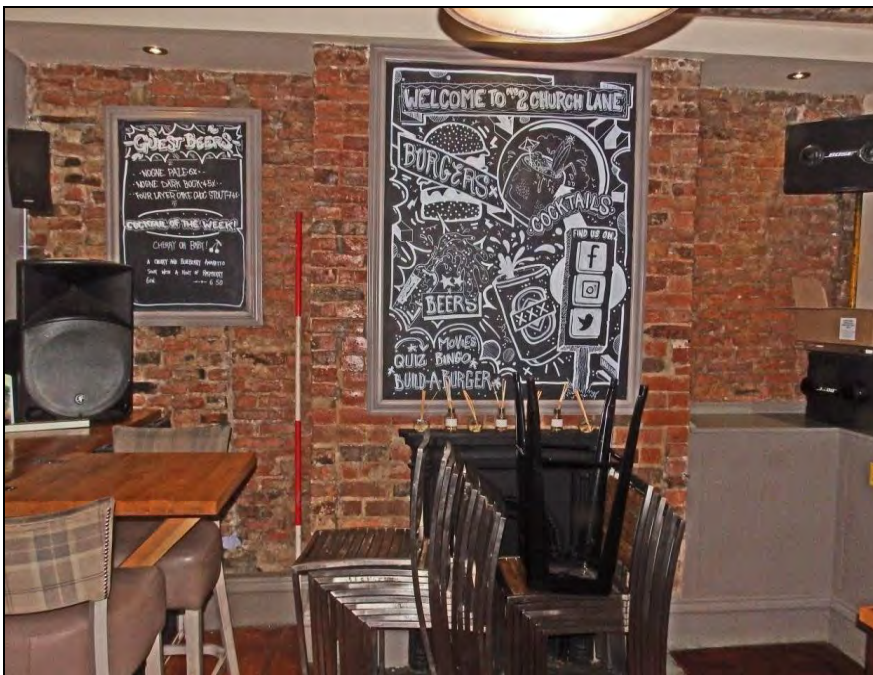
*Illus. 15: Wall E, with blocked doorway to left of chimney breast*

This is the south wall of the ground floor of the Southern Building. At its east end is a doorway into the small square 20th-century block. The wall is of old brick, in a rather irregular bond; close to the doorway is an earlier one, now blocked, with a timber lintel, and midway between that and the west wall is a chimney breast projecting c 0.50 m, of more recent and larger brick. It has a small cast-iron fireplace, with a round arch with cabled rolls on either side of its broad splay, within an earlier and taller opening.

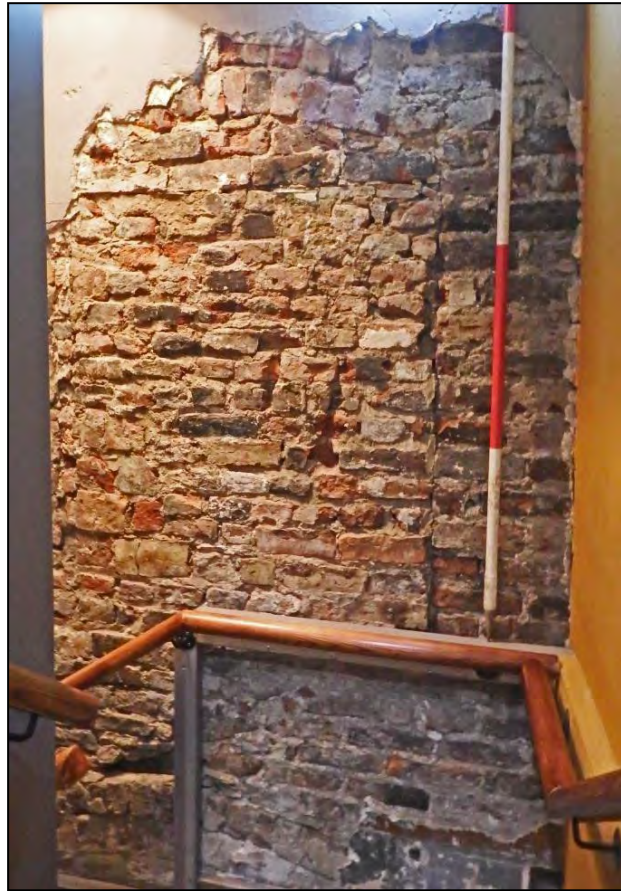
*Illus. 16: Wall F, alongside stair*

Close to the west end of this short length of wall (stone below and brick above, but partly hidden by plaster) is a tall straight joint, straight on the west and ragged on the east, as if an earlier wall on this side had been cut to allow a new building to the west. Adjacent to the joint the wall face steps southwards and is all of brick; in this next section (partly covered by the stair) there has been a ground floor opening with a segmental arch (and a double row of brick voussoirs) and a second similar blocked opening above, in which the segmental arch seems to have been a relieving arch as it is slightly narrower than the opening below. It looks as if its west jamb has been formed by a single-skin brick wall returning south, now cut away.

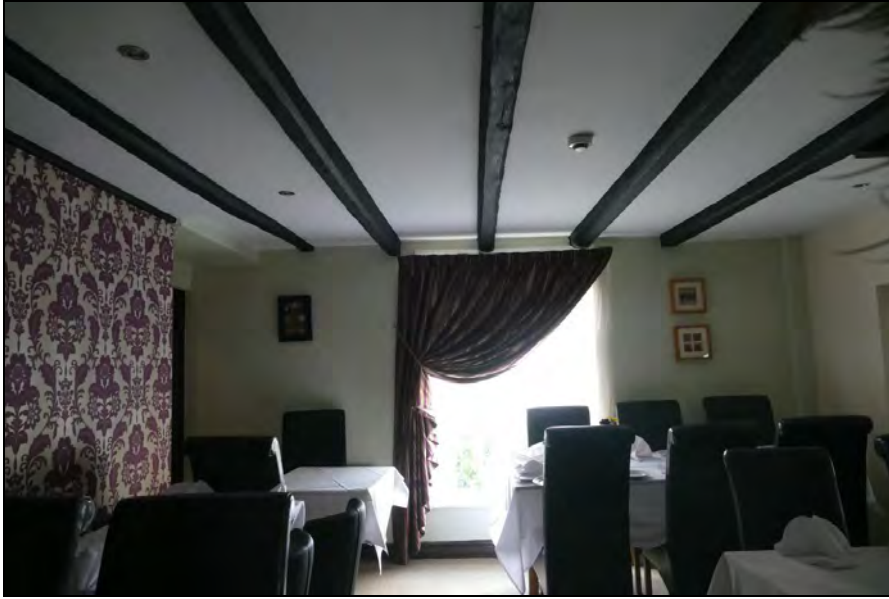
*Illus. 17: Southern Building at first floor level looking west, showing old ceiling beams*

The first floor of the building now forms the northern part of the Moti Raj Tandoori and Balti Restaurant, which also occupies the first floor of the more modern building to the south, and which provides the only access to it. At this level the building has been completely modernised, with many new openings made through dividing walls to integrate the internal spaces. The floor of the northern building is set two steps lower than that of the southern. The only features of any age are five east-west ceiling beams in the Southern Building, of plain rectangular section. At the north end of this section of ceiling is a roof hatch which gives access to the attics.

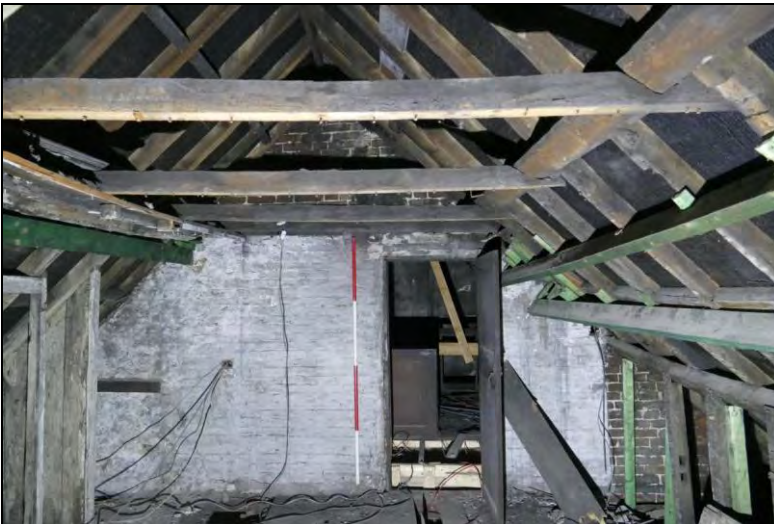
*Illus. 19: Attic of the Southern Building looking north, showing the old two-panel door into the attic of the Northern Building, and the collars with notches to carry purlins; these are probably secondary (see the cuts for earlier purlins on the rafter).*

The door leads through into the attics over the Northern Building, which form an L-plan; the initial section is set north-south, and has a series of collars fixed to the south face of the common rafters, with notched ends to take purlins clasped between rafter and collar; although interesting, this arrangement may be of no great age as there are cuts on the rafters for an earlier purlin (?) at a lower level; there is one truss near the north end that has a similar collar. At the north-east corner of the room is an extruded stud-and-plaster projection, now in poor condition, forming a lobby giving access to the east-west range of attic parallel to High Street West; west of the lobby and set between the two sections of attic is an L-plan brick stack. This east-west roof is of three bays (with a hip at the northwest corner, and appears better preserved. Its trusses have collars, and quite heavy and roughly staggered butt purlins,

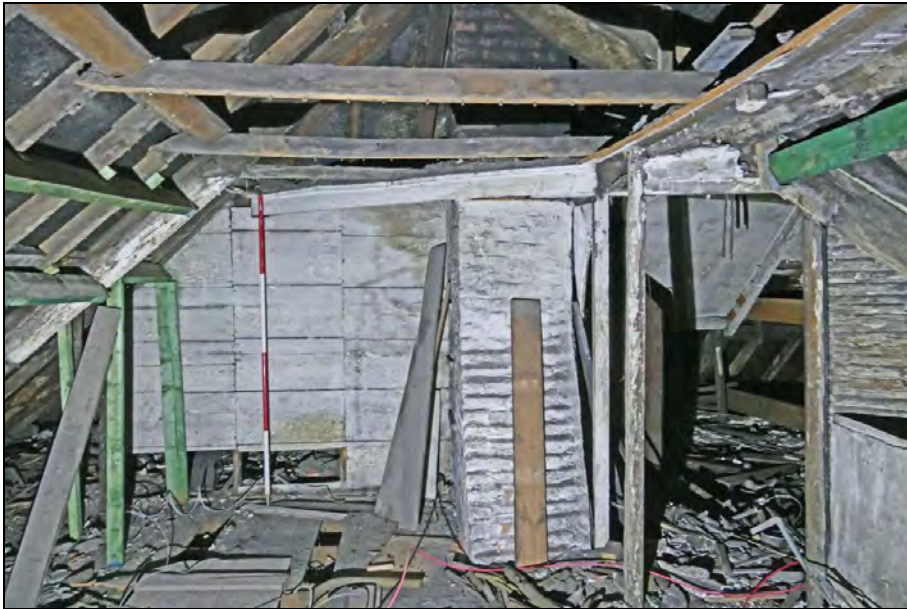
*Illus. 20: Attic of the Northern Building, west part looking north, showing the lobby on the right linking to the south part of attic, and the partition formed by old broad boards*

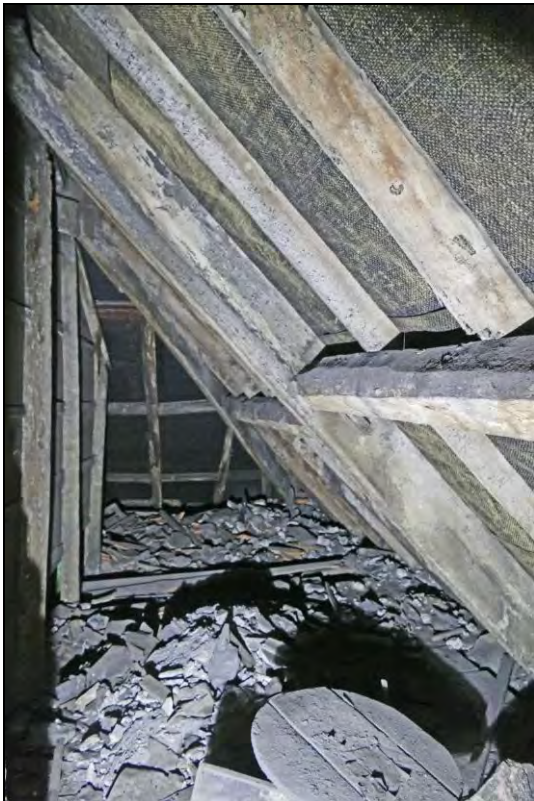
*Illus. 21: North roof slope of the attic of the Northern Building, looking west towards the hipped corner; note the roughly-chamfered staggered butt purlins. This is a less-altered section of roof and may be of relatively early post-medieval date.*

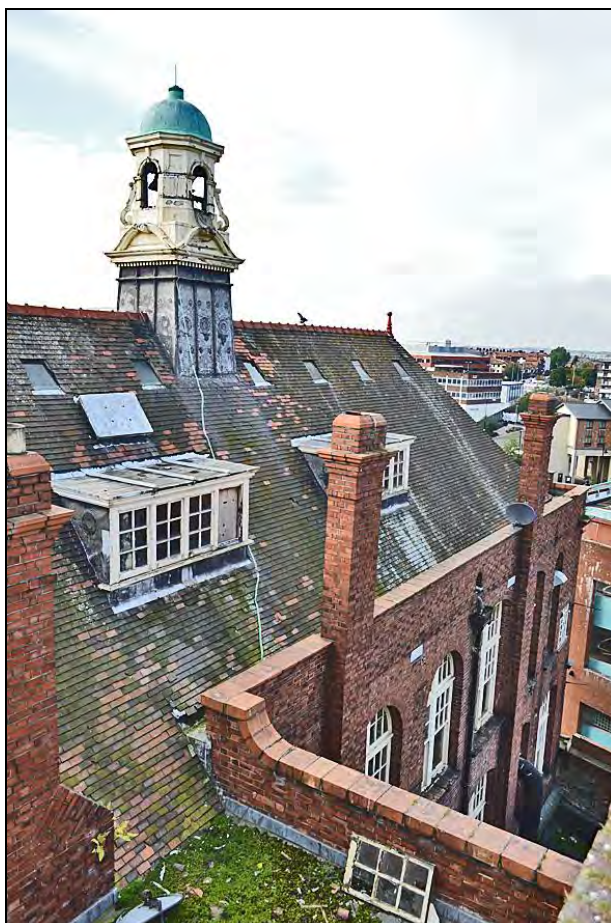
**Frontispiece:** View from roof level looking north-west towards the north part of the east elevation.

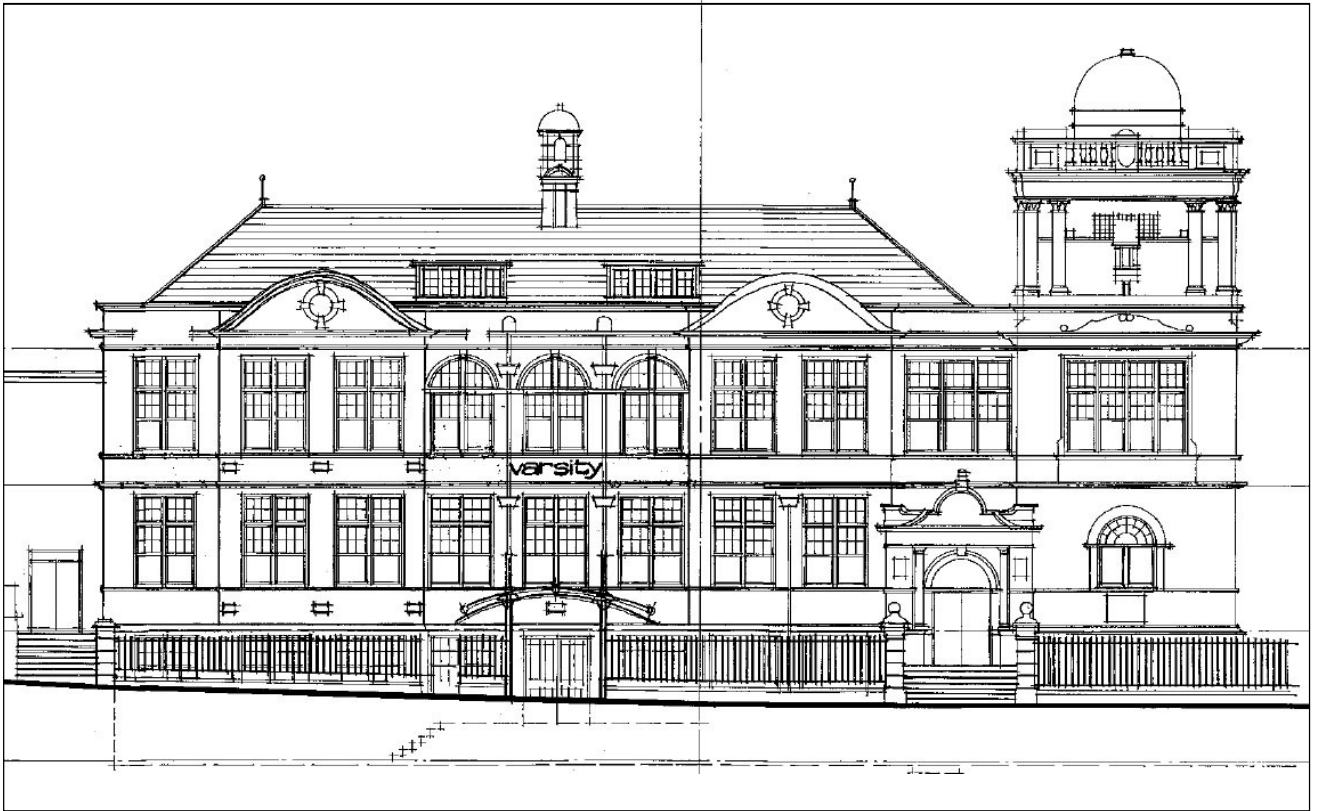
**Illus. 09:** *The West Elevation of the Galen Buildings in 1999 (historical information provided by the applicant/client)*

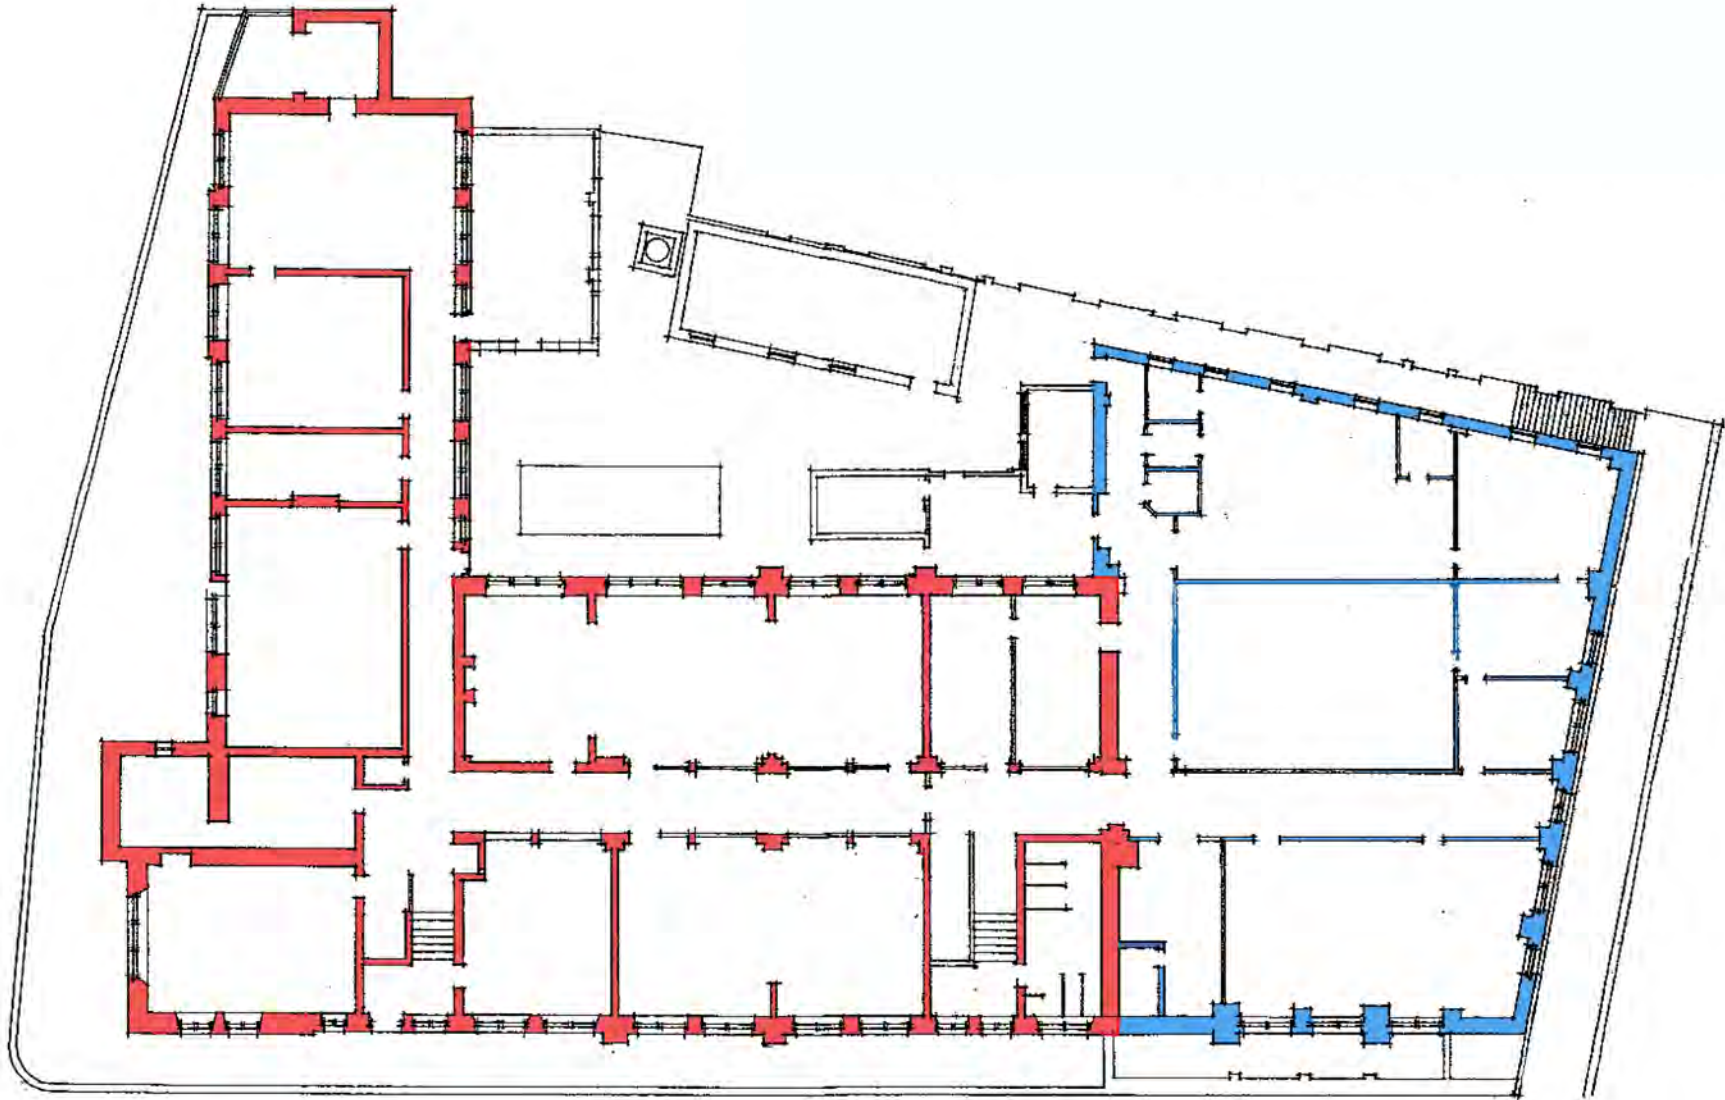
*Illus. 10: Ground Plan of the Galen Buildings, Sunderland prior to c.2000 alterations, showing 1899-1901 building (red infill) and 1928 extension (blue infill).*

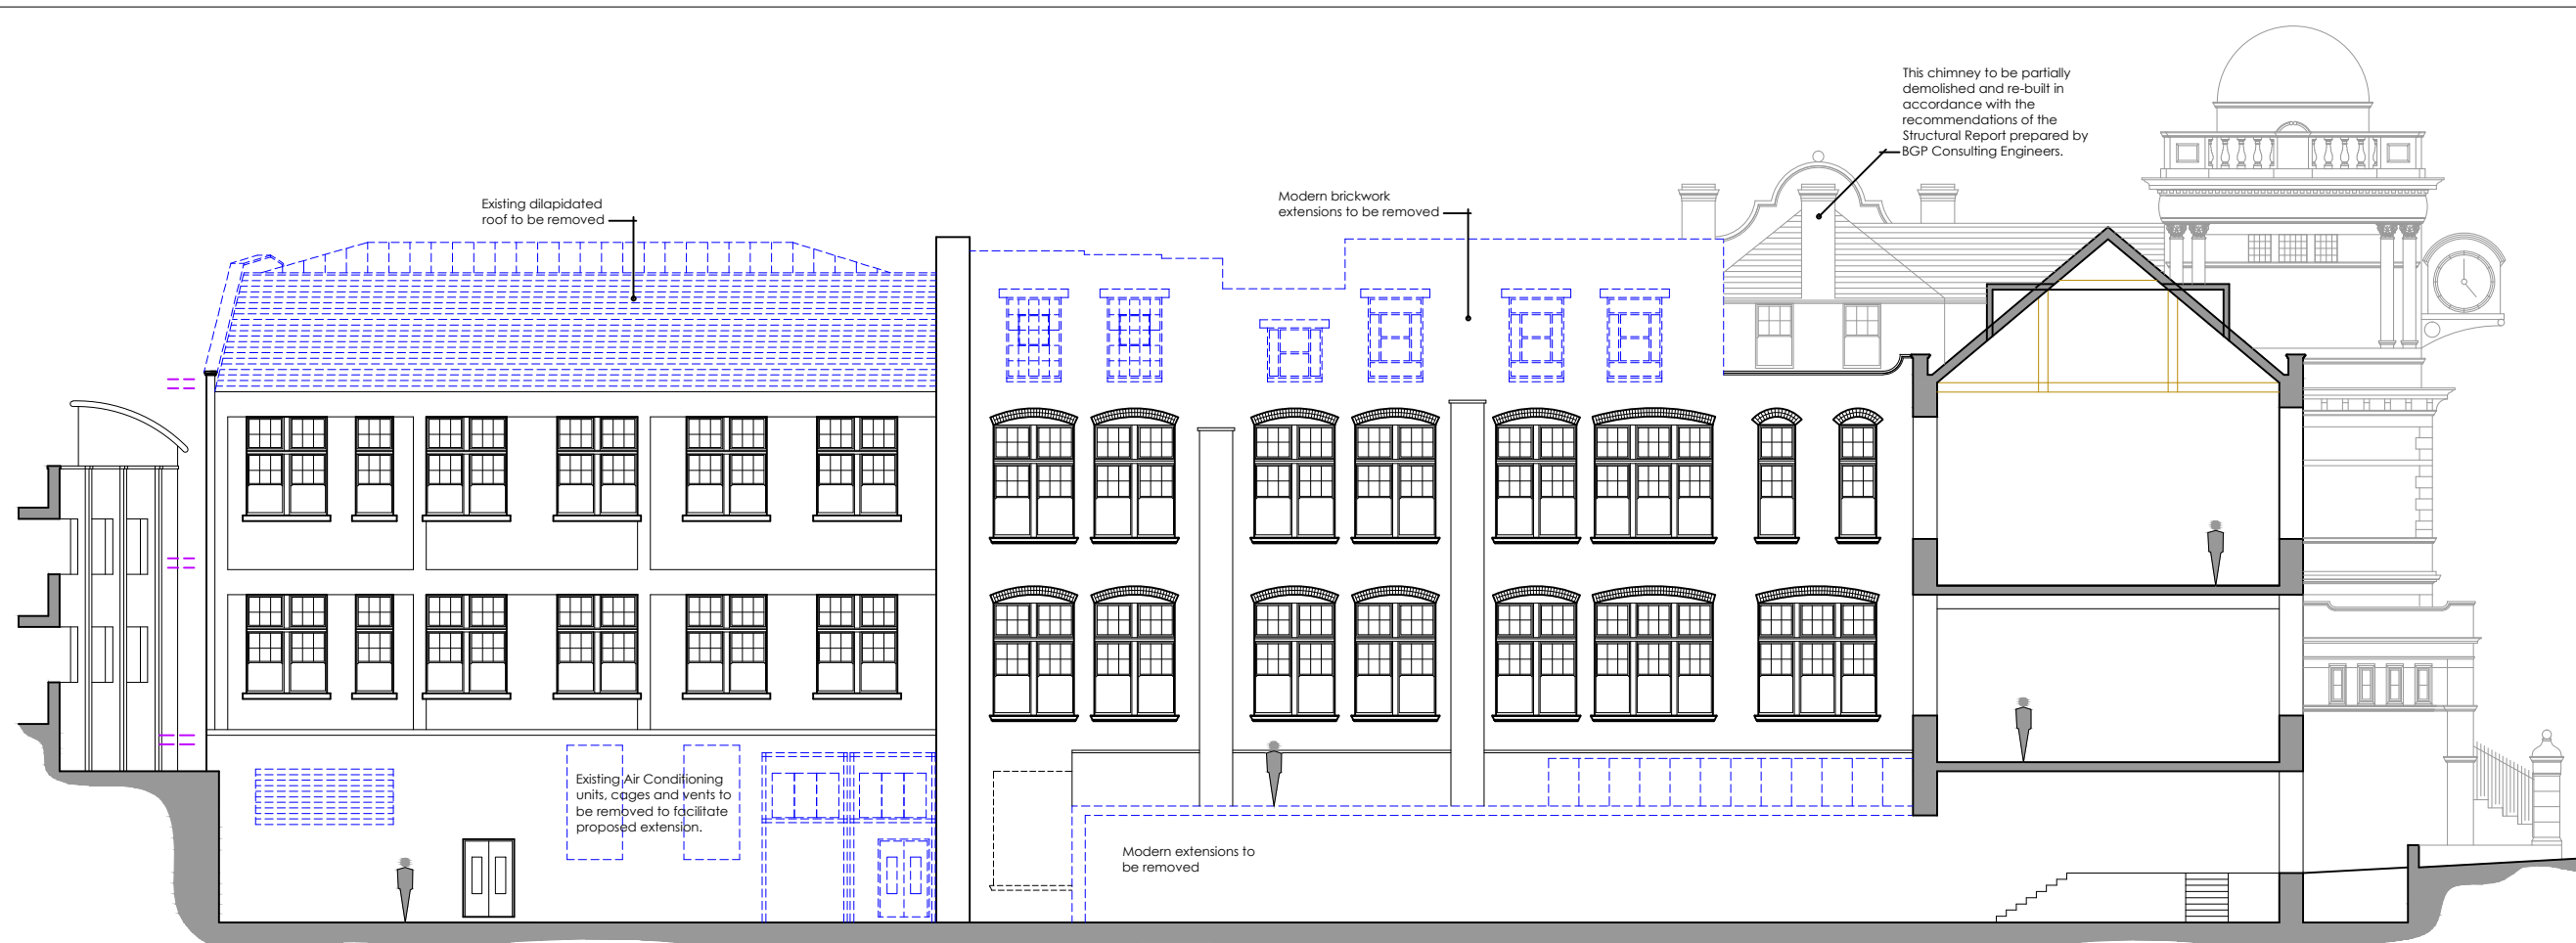
NORTH ELEVATION / SECTION SHOWING PROPOSED DEMOLITIONS

NOTE - A number of existing windows incorporate broken glazed panes, extractor fans, louvres etc. All of the windows are to be sympathetically refurbished and redecorated. Secondary glazing is to be incorporated internally in accordance with the acoustic report prepared by Environmental Noise Solutions Limited.

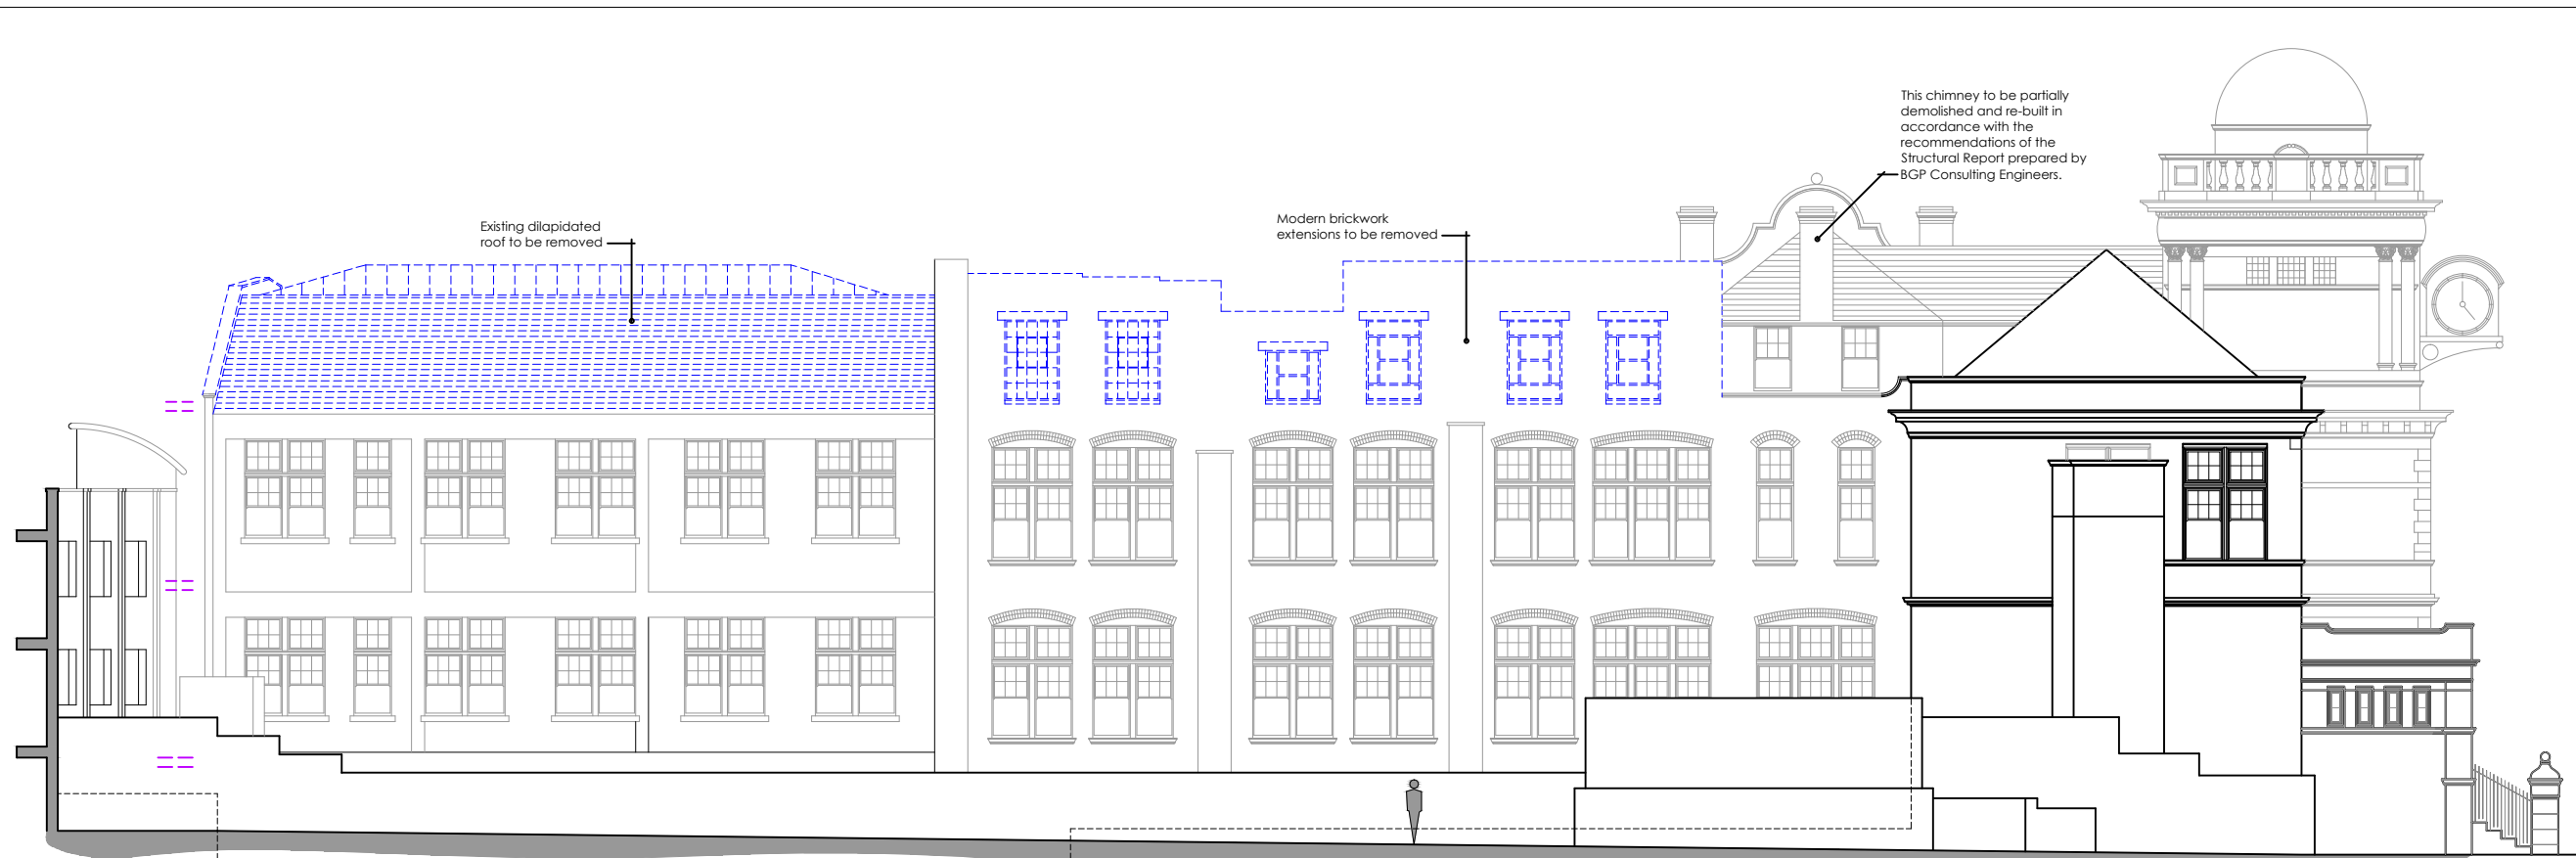
NORTH ELEVATION SHOWING PROPOSED DEMOLITIONS

NOTE - A number of existing windows incorporate broken glazed panes, extractor fans, louvres etc. All of the windows are to be sympathetically refurbished and redecorated. Secondary glazing is to be incorporated internally in accordance with the acoustic report prepared by Environmental Noise Solutions Limited.

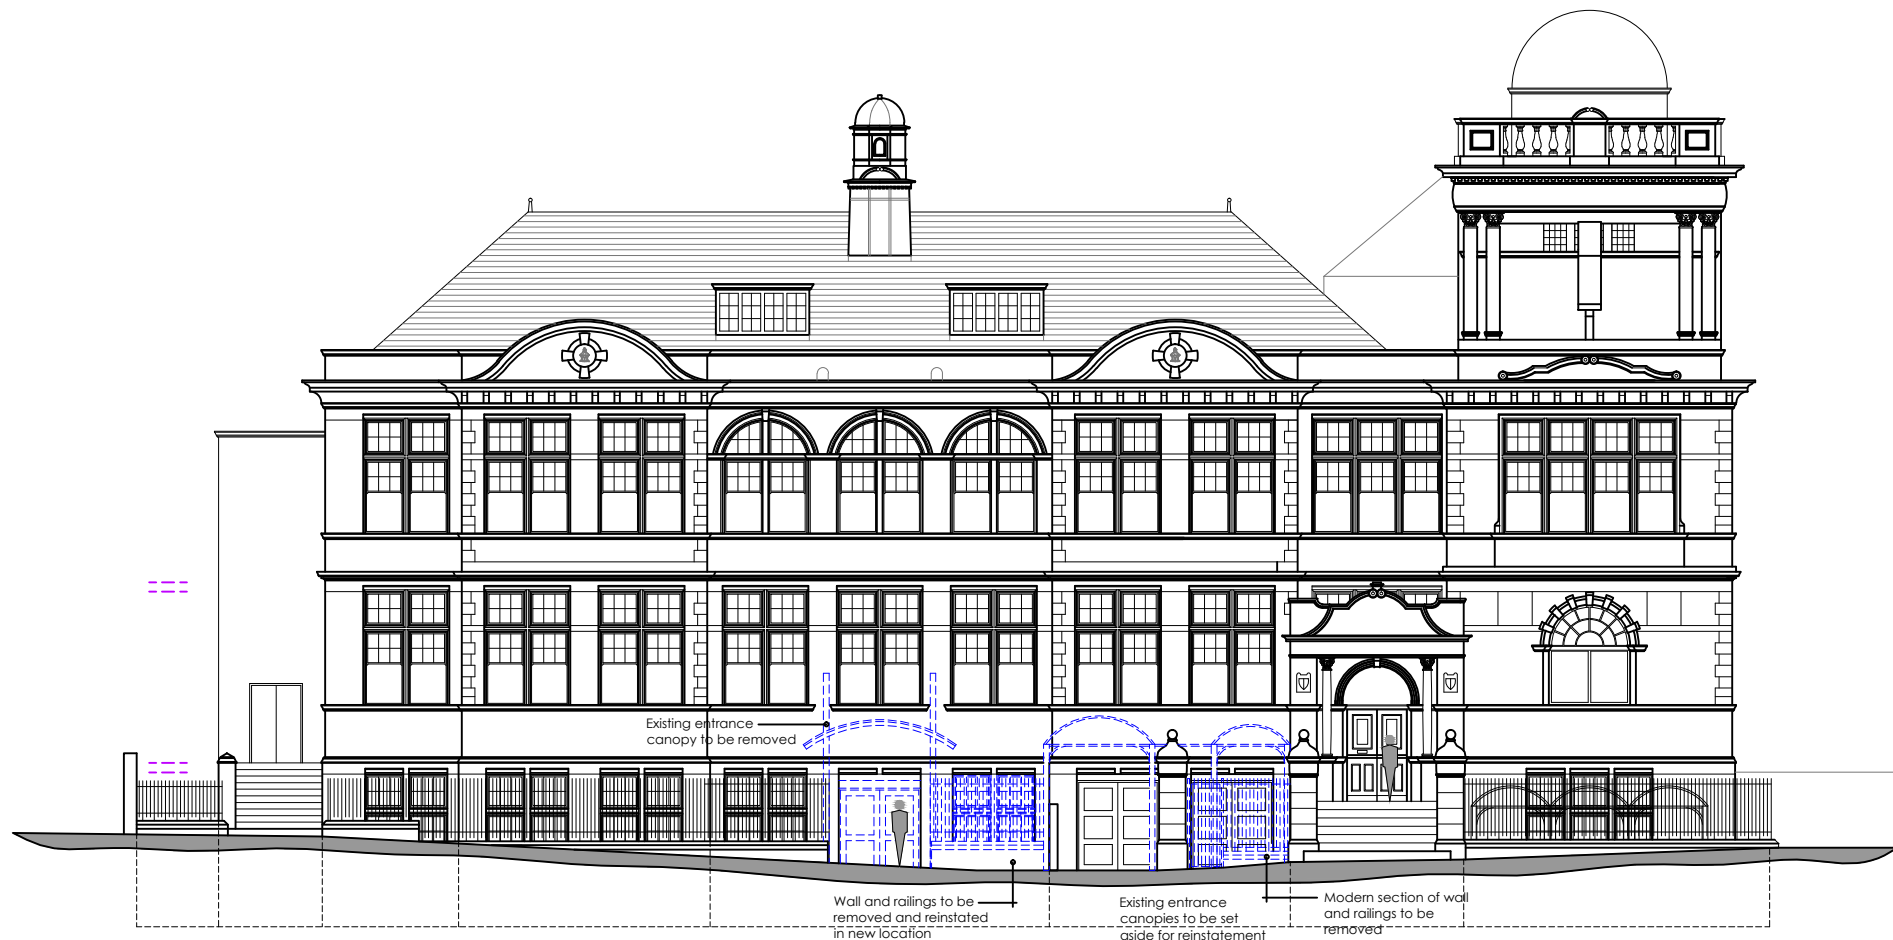
## WEST ELEVATION SHOWING PROPOSED DEMOLITIONS

NOTE - A number of existing windows incorporate broken glazed panes, extractor fans, louvres etc. All of the windows are to be sympathetically refurbished and redecorated. Secondary glazing is to be incorporated internally in accordance with the acoustic report prepared by Environmental Noise Solutions Limited.

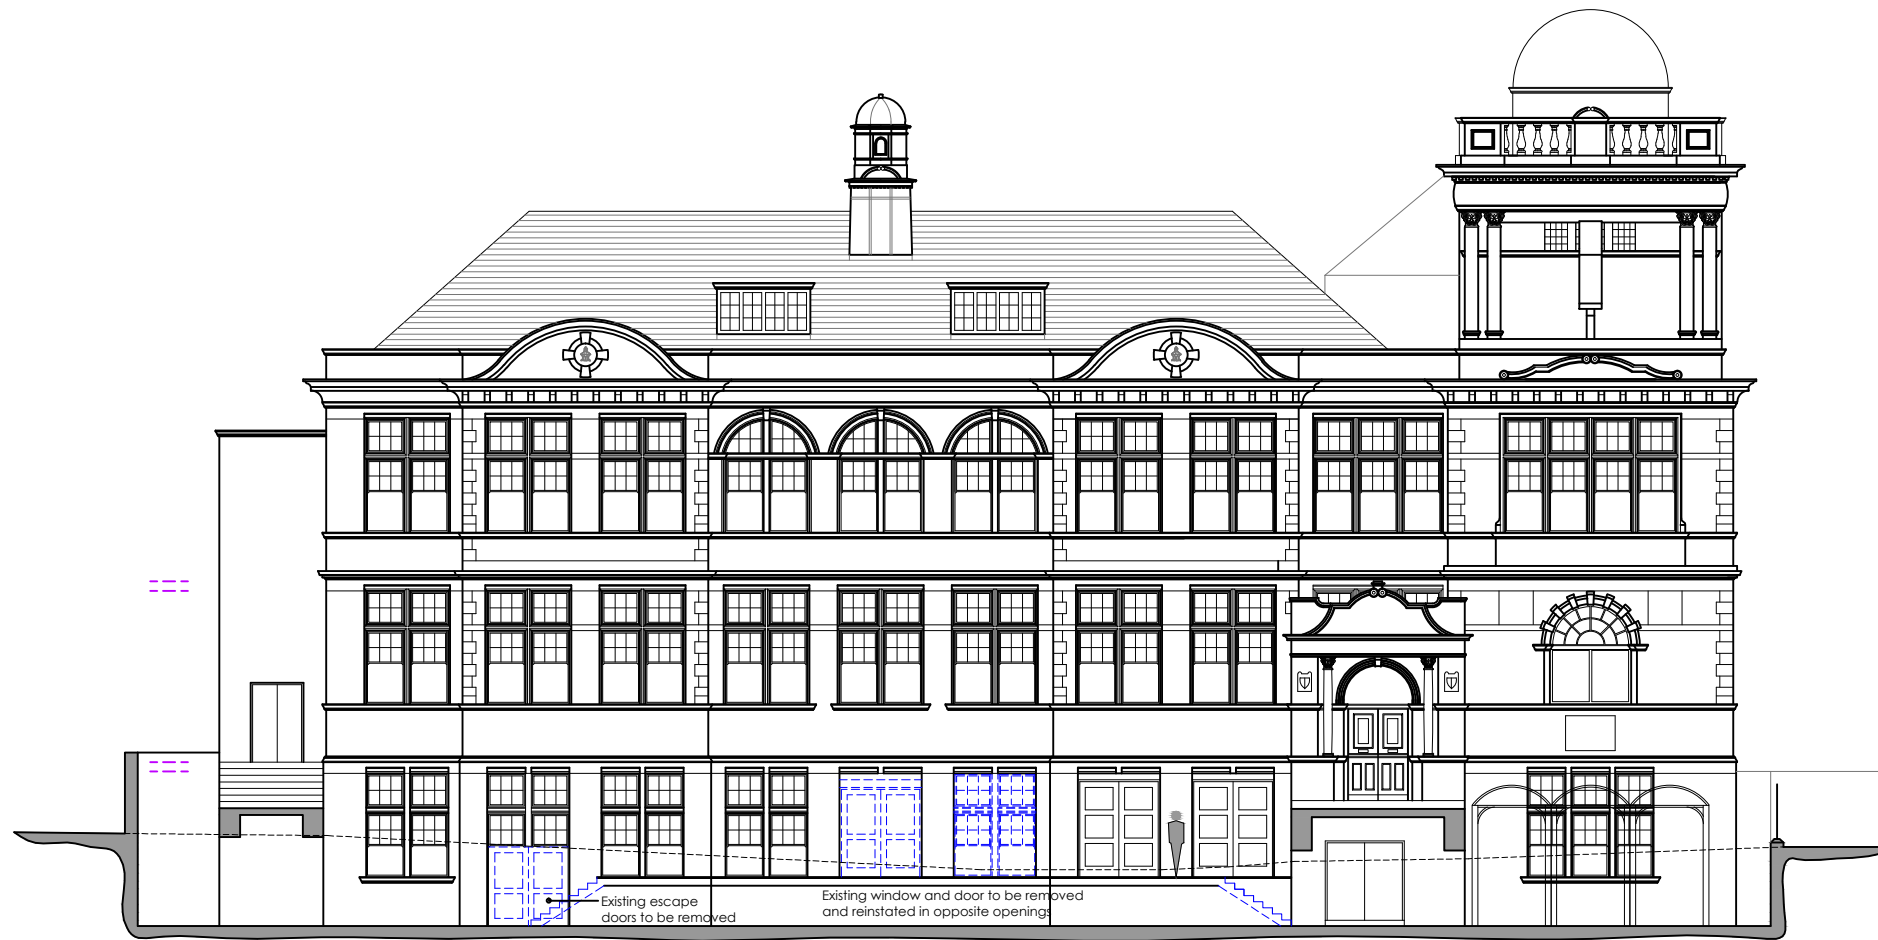
WEST ELEVATION THROUGH LIGHT WELL SHOWING PROPOSED DEMOLITIONS

NOTE - A number of existing windows incorporate broken glazed panes, extractor fans, louvres etc. All of the windows are to be sympathetically refurbished and redecorated. Secondary glazing is to be incorporated internally in accordance with the acoustic report prepared by Environmental Noise Solutions Limited.
