**BISHOPWEARMOUTH:**  
*A HISTORICAL VILLAGE ATLAS*  
*Part 2: Supplementary Reports*

Produced by  
The Archaeological Practice Ltd & the Bishopwearmouth Village Atlas Group

NOS. 1-2 CHURCH LANE AND  
314-315 HIGH STREET  
BISHOPWEARMOUTH  
SUNDERLAND

HISTORIC BUILDING RECORD

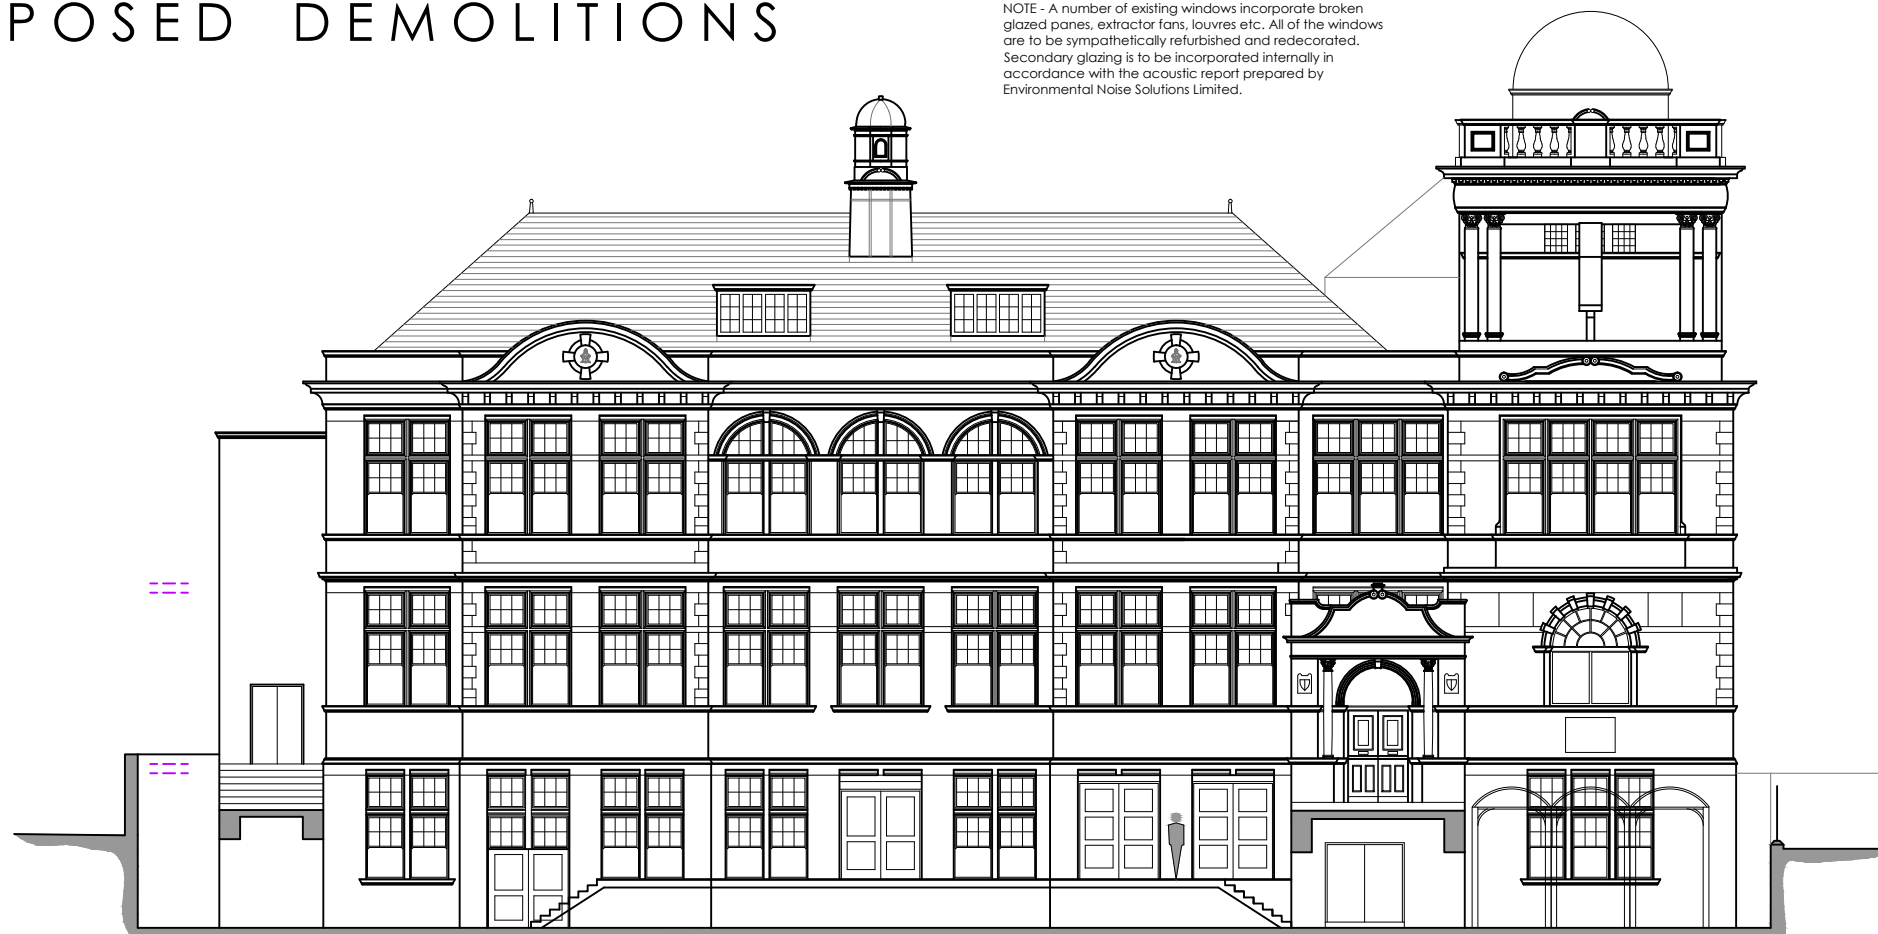
WEST ELEVATION THROUGH LIGHT WELL AS EXISTING

WEST ELEVATION THROUGH LIGHT WELL SHOWING PROPOSED DEMOLITIONS

NOTE - A number of existing windows incorporate broken glazed panes, extractor fans, louvres etc. All of the windows are to be sympathetically refurbished and redecorated. Secondary glazing is to be incorporated internally in accordance with the acoustic report prepared by Environmental Noise Solutions Limited.

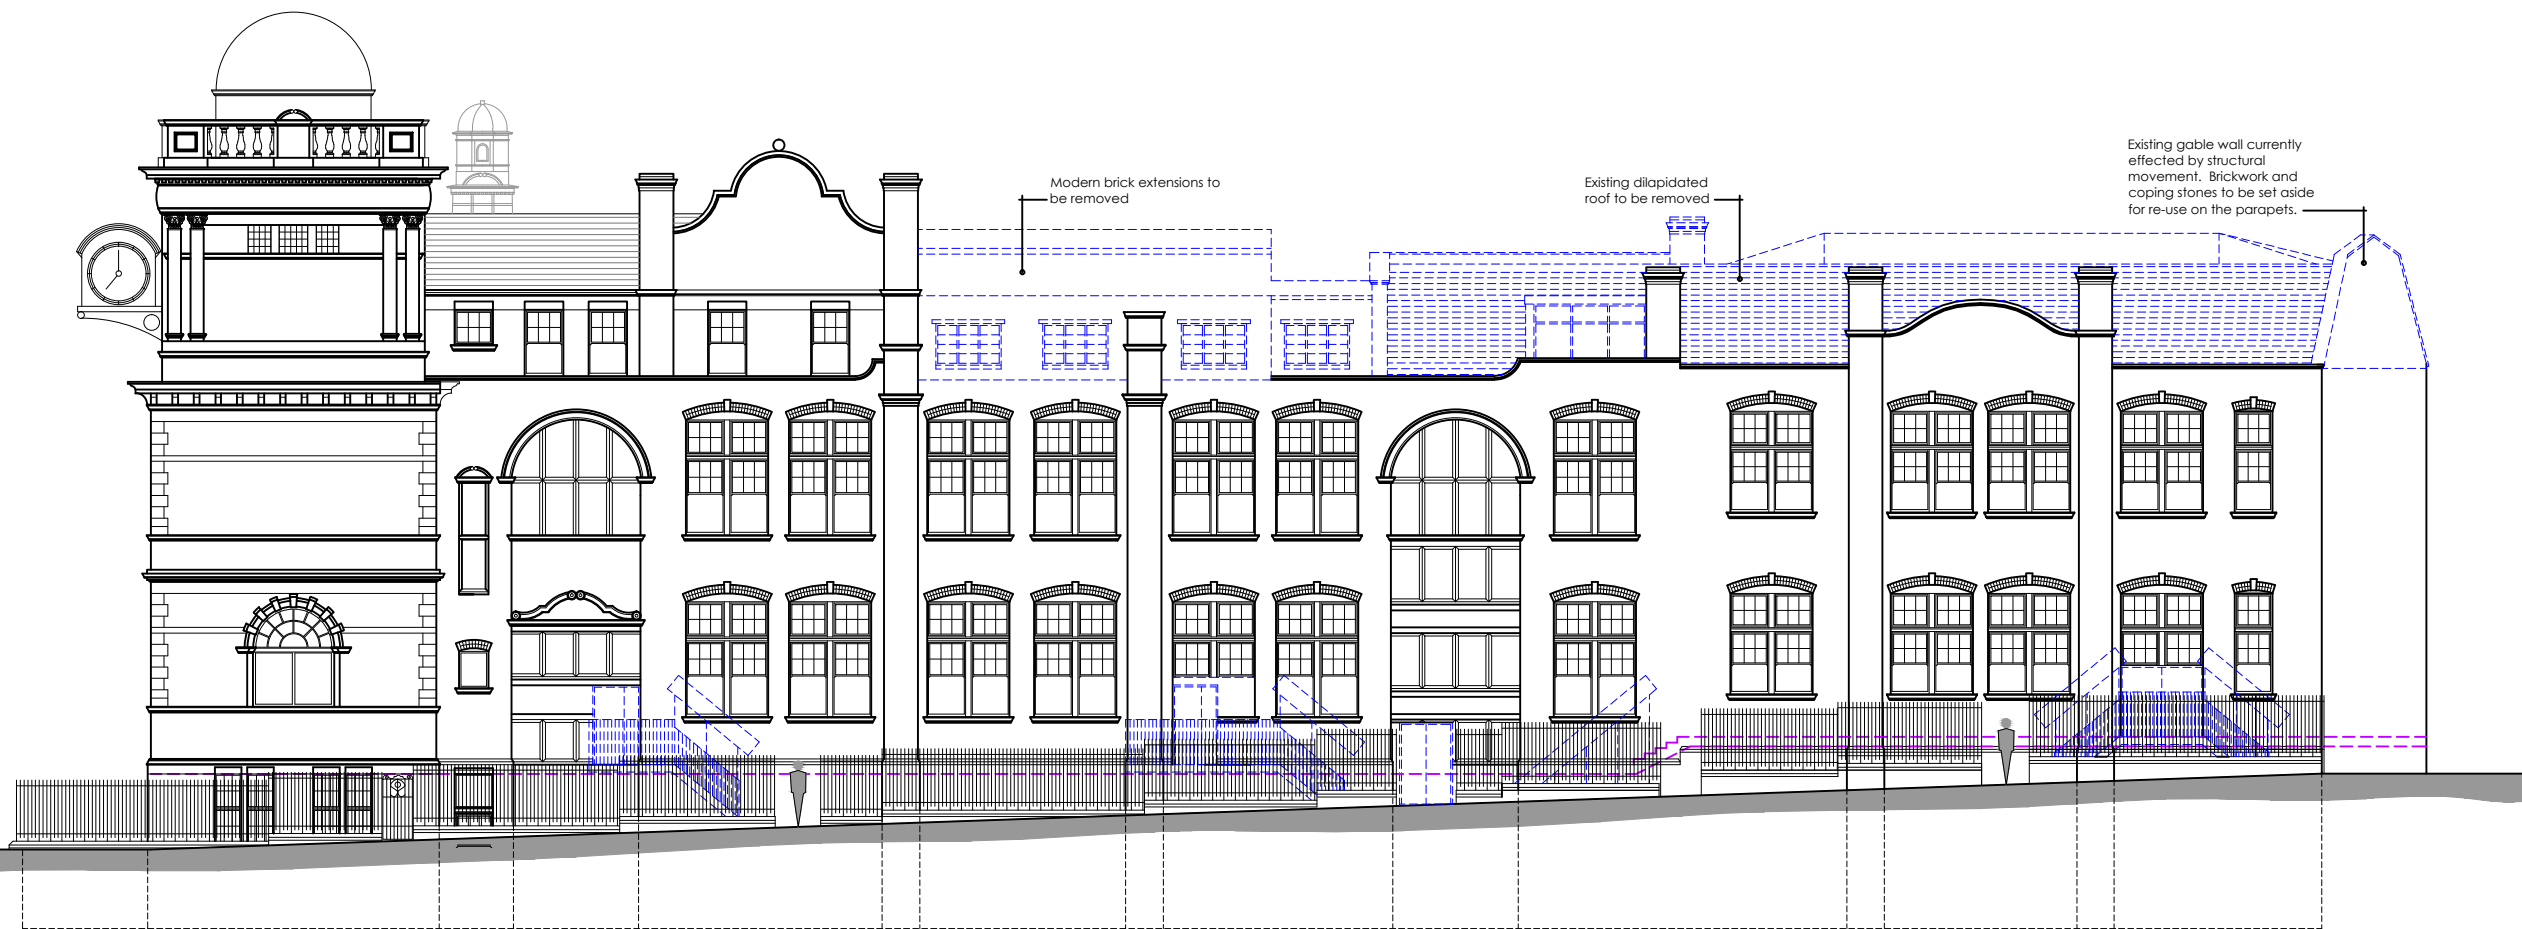
SOUTH ELEVATION SHOWING PROPOSED DEMOLITIONS

NOTE - A number of existing windows incorporate broken glazed panes, extractor fans, louvres etc. All of the windows are to be sympathetically refurbished and redecorated. Secondary glazing is to be incorporated internally in accordance with the acoustic report prepared by Environmental Noise Solutions Limited.

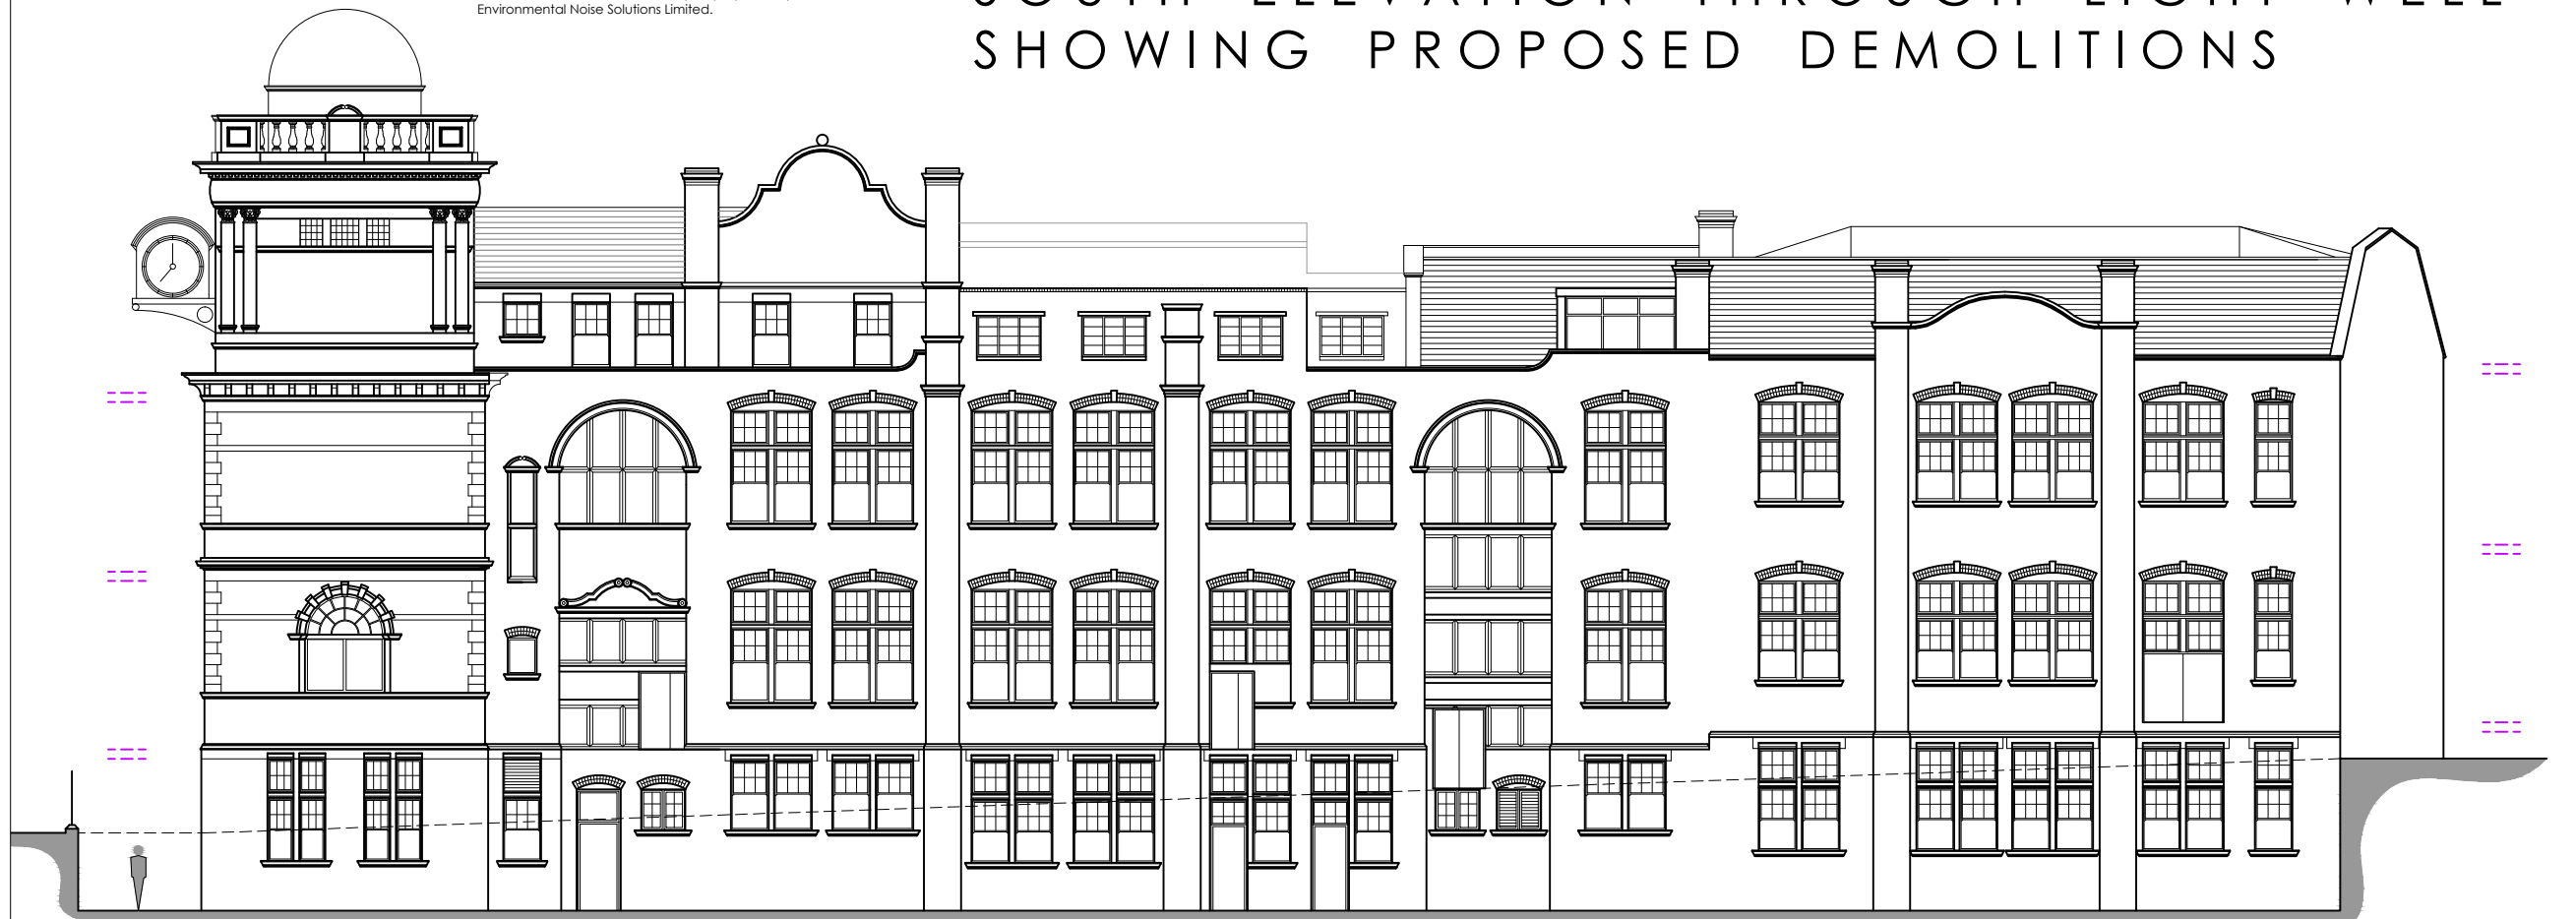
## SOUTH ELEVATION THROUGH LIGHT WELL AS EXISTING (Facing Alley)

NOTE - A number of existing windows incorporate broken glazed panes, extractor fans, louvres etc. All of the windows are to be sympathetically refurbished and redecorated. Secondary glazing is to be incorporated internally in accordance with the acoustic report prepared by Environmental Noise Solutions Limited.

Existing doors and frames to be removed to allow reinstatement of windows

## SOUTH ELEVATION THROUGH LIGHT WELL SHOWING PROPOSED DEMOLITIONS

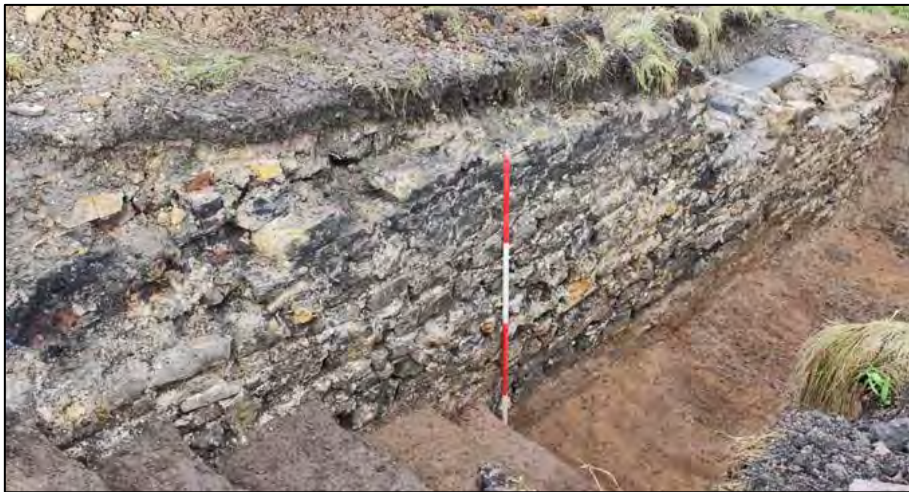
***Frontispiece:*** View north-eastwards along the south-east face of the stone-built end wall of a demolished block of terraced housing revealed in the first phase of Trench 3 excavation.

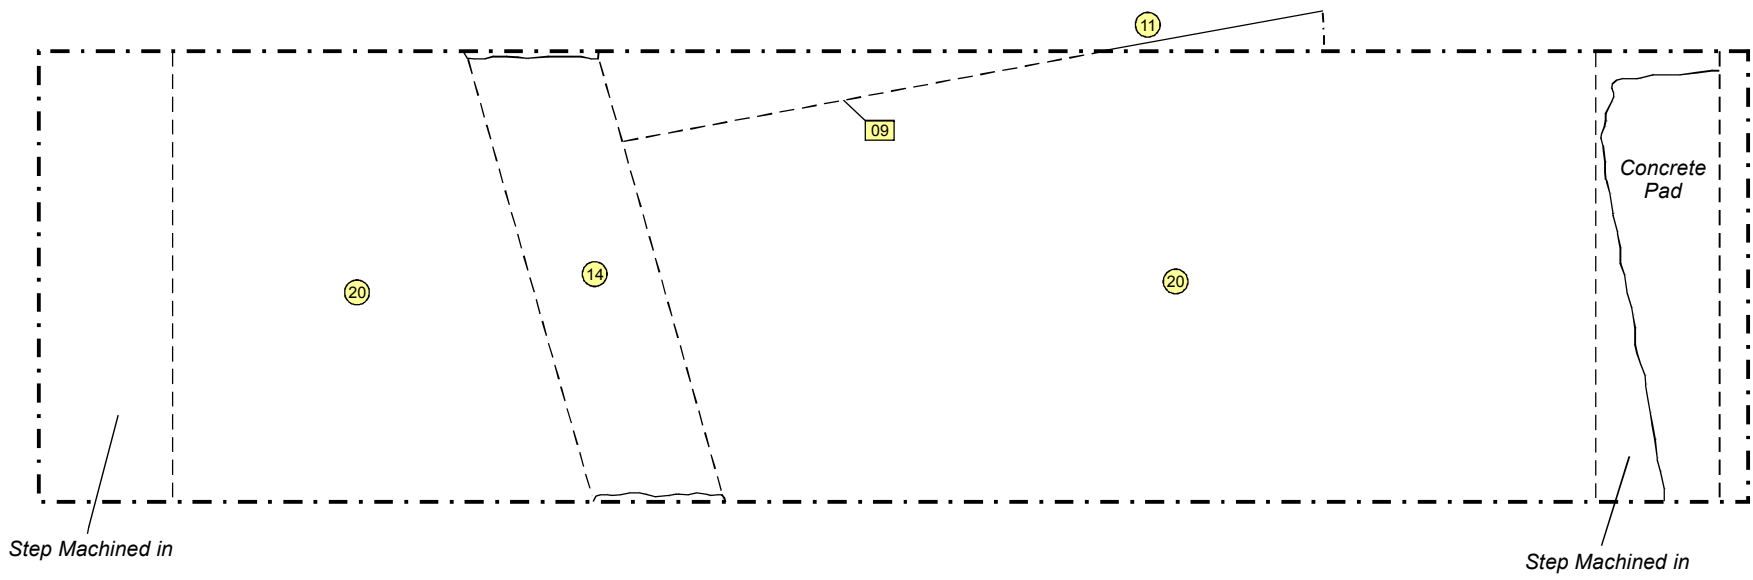
The lower parts of the trench sections and trench floor were comprised of clean brown clay interpreted as the natural boulder clay.

**Illus. 18:** Plan of Trench 1, Hind Street Hotel Site, Sunderland.

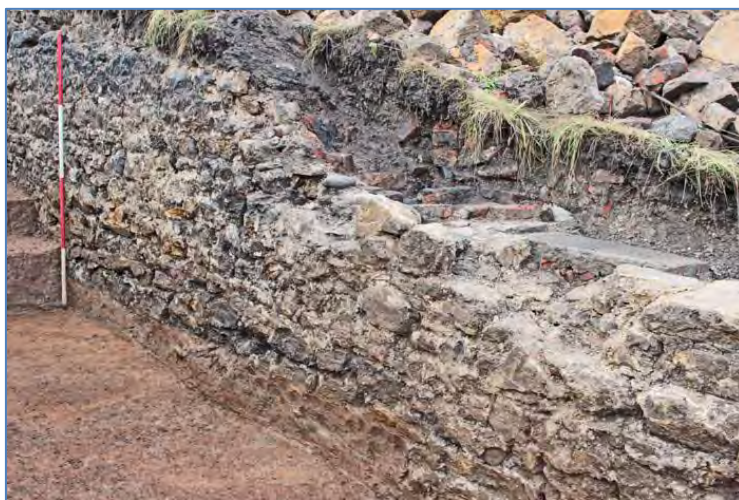
cottage comprised of a poured concrete level floor, with a partial brick partition wall aligned NW-SE, 5.70 m from and parallel with the aforementioned concrete end/revetment wall at the top (Hope Street) end of the trench. Two fireplace hearths were recorded – one in each (room?) of the north-west internal elevation of the partitioned building, both showing signs of alteration (by narrowing). A partial polished concrete floor (with geometric pattern at the north-east end) for the front yard was observed adjoining the north-east wall of the cottage exterior, along with drainage pipe and grate. A repaired sandstone step with ceramic floor tiles and a possible threshold was observed abutting the south corner of the building exterior.

*Illus. 24:  
View from the south-east of a stone-built end wall of a  
House or cottage block uncovered in evaluation Trench 3.*

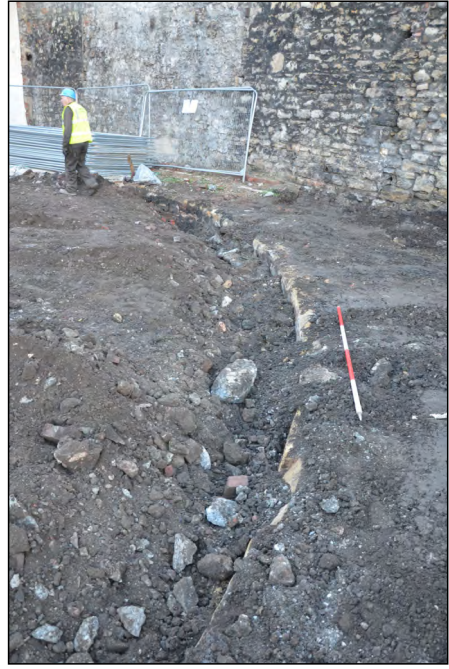
Photo 01.

The gas tank as revealed by the excavations survived well, although some damage was caused to the otherwise regular arrangement of stone blocks around its upper circumference by heavy machinery and localised groundworks. Following the excavation of its toxic fill which, close to the floor of the tank comprised a silty black deposit, the tank was back-filled with non-toxic material and the surface compacted for re-use within the proposed development.

Photo No.	Illus.	
01	Illus. 116:	The west side of the gas tank emerging at the foot of the east elevation of the Hope Street boundary wall (extending northwards from the north-west corner of the Retort House).
02	Illus. 117:	The emergence of the west side of the gas tank viewed from the north (towards the Retort House).
03	Illus. 118:	The emergence of the north-east part of the gas tank viewed from the south-west (towards the former Gas Works offices).
04	Illus. 110:	The west side of the gas tank following partial excavation, at the foot of the Hope Street boundary wall
05	Illus. 120:	The south-west part of the gas tank following partial excavation.
06	Illus. 121:	Detail of stonework forming the upper part of the gas tank lining.
07	Illus. 122:	The west side of the gas tank during further excavation.
08	Illus. 123:	Detail of disturbed masonry in the upper courses of the north part of the gas tank structure.

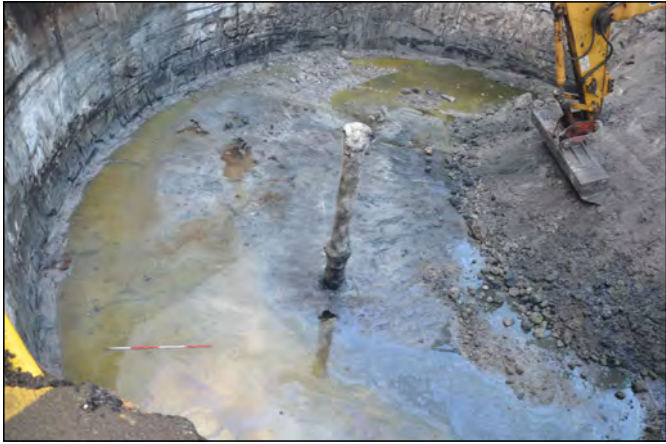
Photo 09.

09	Illus. 124:	View from the north-east following complete excavation of the gas tank, with Retort House to rear.
10	Illus. 125:	Vertical oblique view (from east side) of the excavated gas tank – 2 metre measuring rod provides scale.
11	Illus. 126:	Sandstone blocks removed from the upper courses of the surviving gas tank sub-structure.
12	Illus. 127:	The excavated gas tank viewed from the north.

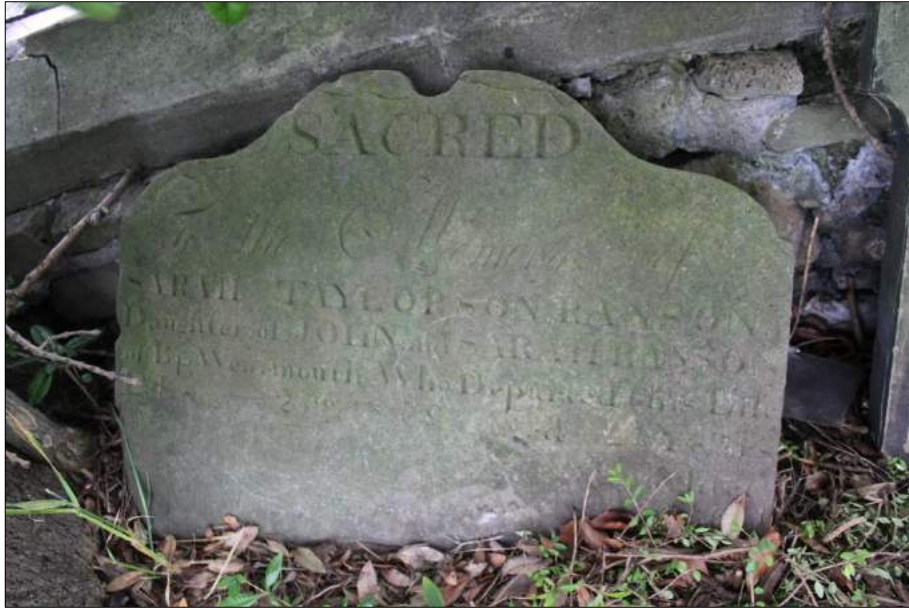
*Plate 1: Headstone 100, looking east, no scale*

- 7.1 Headstone 100 comprised the upper part of a sandstone headstone with a partial inscription present (Plate 1). The headstone fragment measured 0.91m x 0.65m x 0.07m thick, and had a curved, shouldered top. The inscription was recorded as:

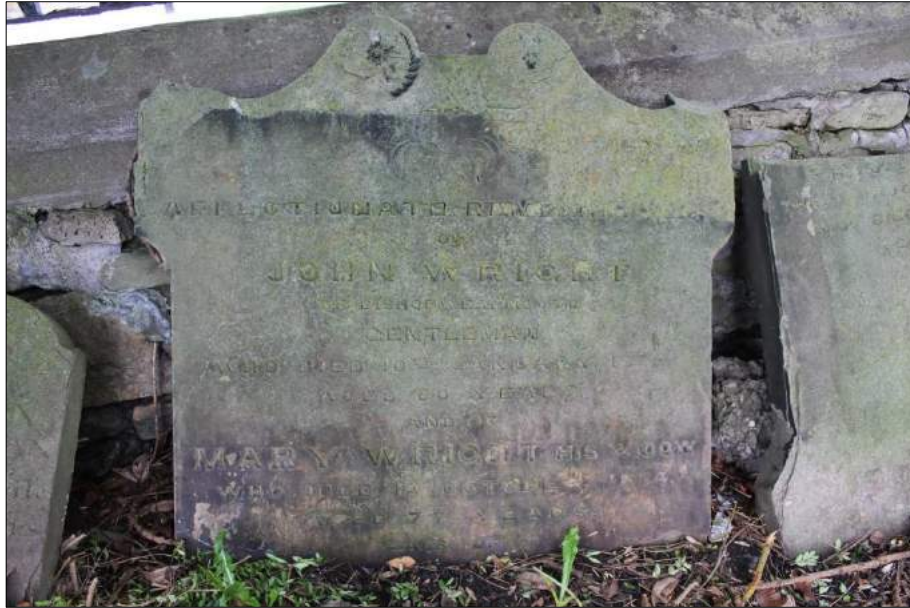
*Plate 2: Headstone 101, looking east, no scale*

- 7.3 Headstone 101 comprised the upper part of a green sandstone headstone with a scroll top with cable and flower decoration (Plate 2). The headstone measured 0.94m x 0.85m x 0.08m thick, and the upper part was heavily weathered. The legible part of the inscription was recorded as:

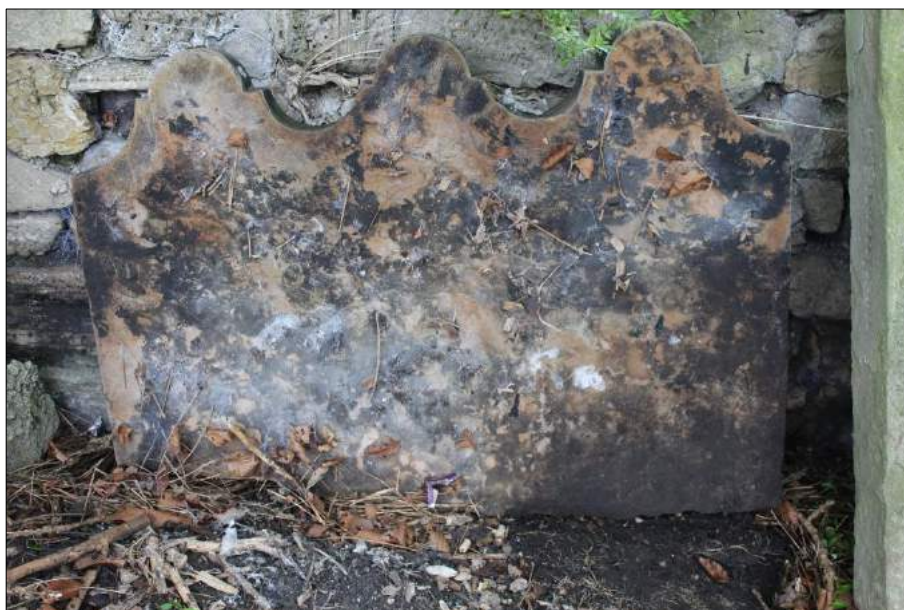
*Plate 4: Headstone 103, looking east, no scale*

- 7.7 Headstone 103 comprised the upper part of an ornately decorated red sandstone headstone with an illegible inscription, the only readable part was possibly the single letter 'W' (Plate 4). The headstone fragment measured 0.91m x 0.66m x 0.08m thick.

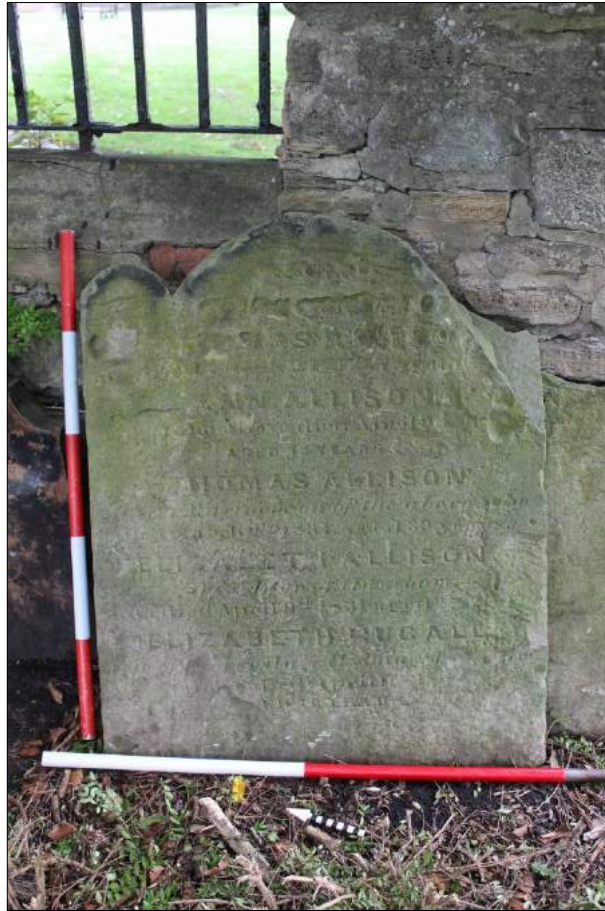
*Plate 5: Headstone 104, looking east, 1m scales*

- 7.8 Headstone 104 comprised an entire headstone with a curved, shouldered top, executed in green sandstone. The stone measured 1.08m in height by 0.85m in width and was 0.08m thick. The inscription was recorded as:

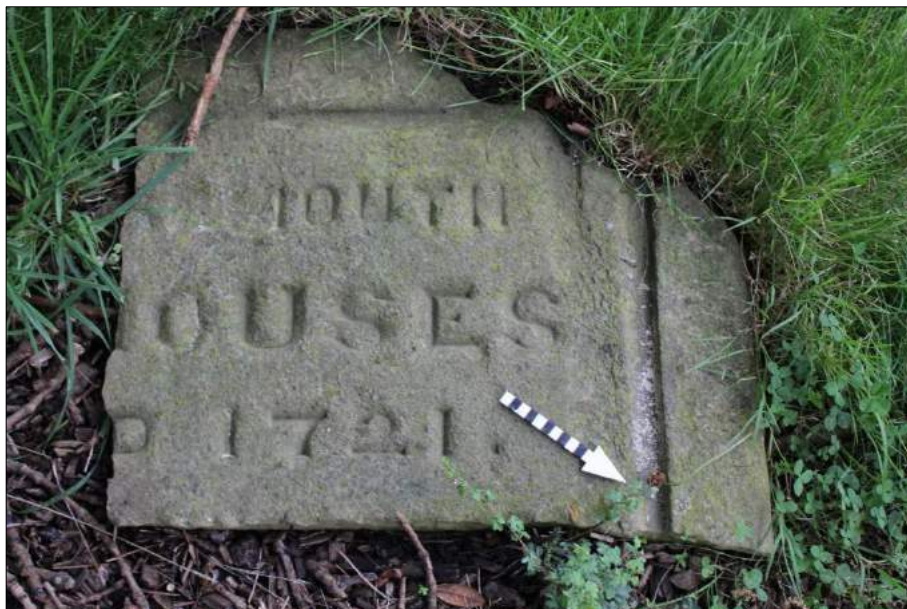
*Plate 7: Plaque fragment 106, 0.10m scale*

7.12 Three green sandstone masonry fragments comprised parts of a commemorative stone plaque originally built into the wall of the Bowes almshouses, adjacent to Bishopwearmouth Green, and which continued in use until 1961. Fragment 106 measured 0.68m x 0.57m x 0.06m (Plate 7). The partial inscription was recorded as:

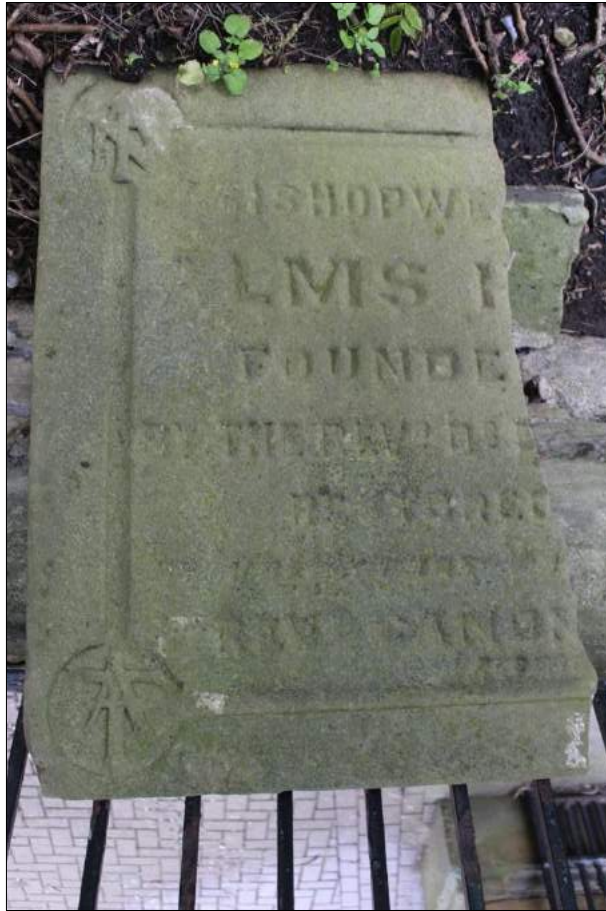
*Plate 8: Commemorative plaque fragment 107, no scale*

7.13 Plaque fragment 107 measured 1.07m x 0.79m x 0.06m, and had a partial inscription that was recorded as:

- 7.14 There was also a monogram, AT or TA, in the bottom left corner of the plaque, and another, possibly NI or IN, in the top left corner. The monograms may represent the initials of the stonemasons involved in the production of the plaque.

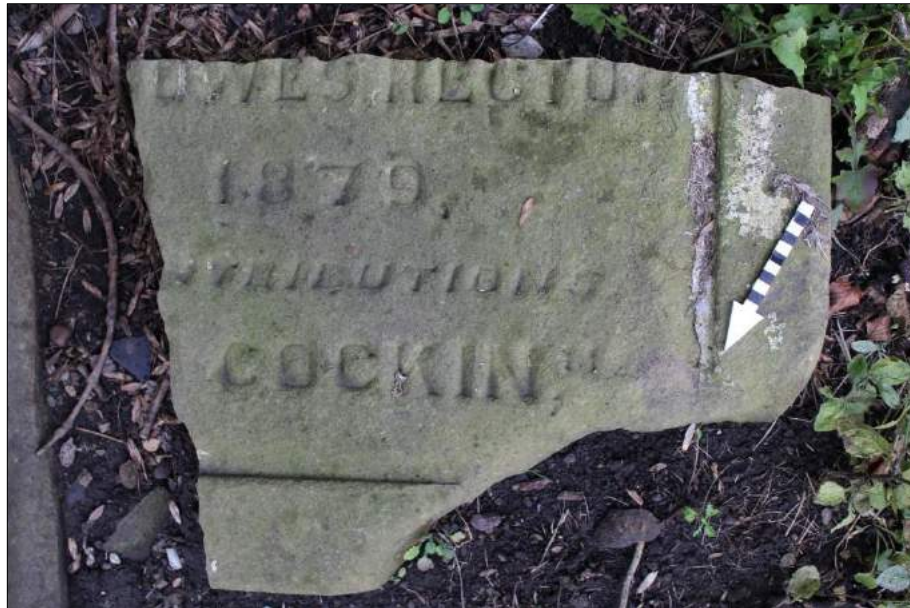
*Plate 8: Commemorative plaque fragment 108, 0.10m scale*

- 7.15 Masonry fragment 108 measured 0.66m x 0.50m x 0.06m, and the partial inscription was recorded as:

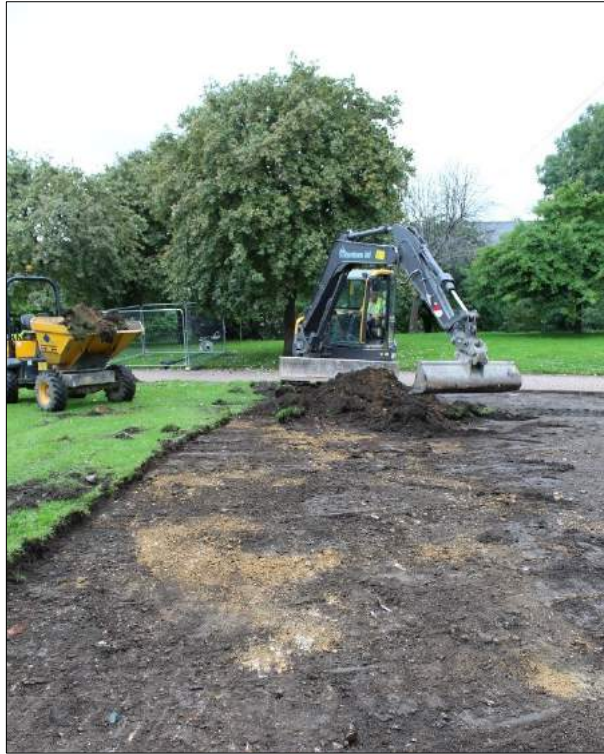
*Plate 9: Topsoil stripping of area of the compound, looking west*

7.18 Two areas of topsoil stripping were monitored in the southeast of the site, for the placement of the site compound (Plate 9), and for a temporary footpath diversion to allow public access to the park during the works (Plate 10). The depth of the strip did not impact upon archaeological deposits or features, removing only modern topsoil, 111.

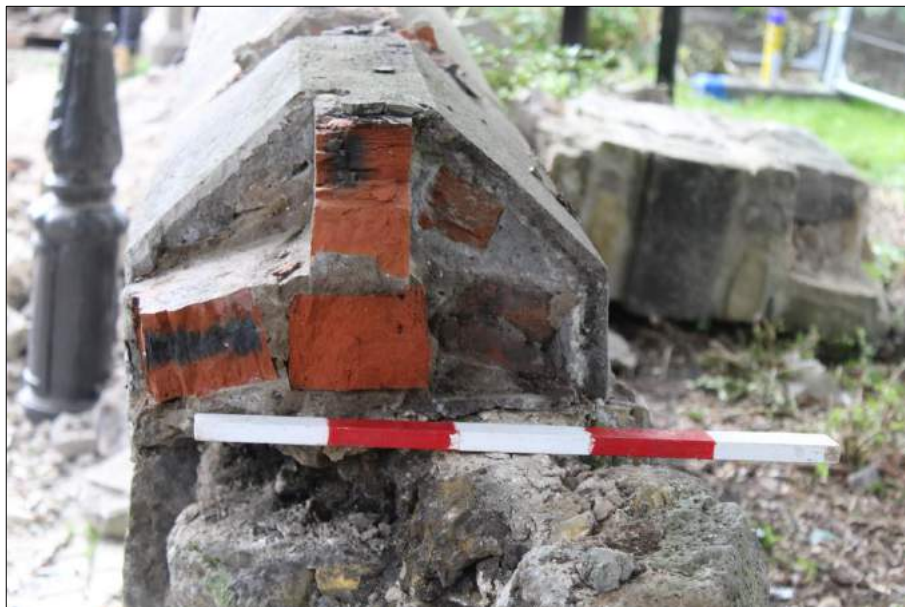
- 7.20 Both walls were constructed of magnesian limestone, with lower courses of sandstone, suggesting that there may have been more than one phase of construction. The chamfered coping on the walls comprised brick and concrete, with many of the bricks utilised stamped OWC (Plate 12). OWC stamped bricks have previously been found at Throckley and Jarrow on Tyneside and in northeast Scotland, mainly on coastal sites and including Orkney and Shetland. The bricks are likely to be the product of a colliery brickworks in the North East coalfield, but their origin has not been positively identified. It has been suggested that they may have been made at Osmondcroft & Whorley Hill Colliery near Barnard Castle, County Durham by the Osmondcroft Coal and Brick Company, although this is not certain (Ian Suddaby, *pers comm*).

*Plate 11: Construction of wall coping, walls 110 and 133, 0.50m scale*

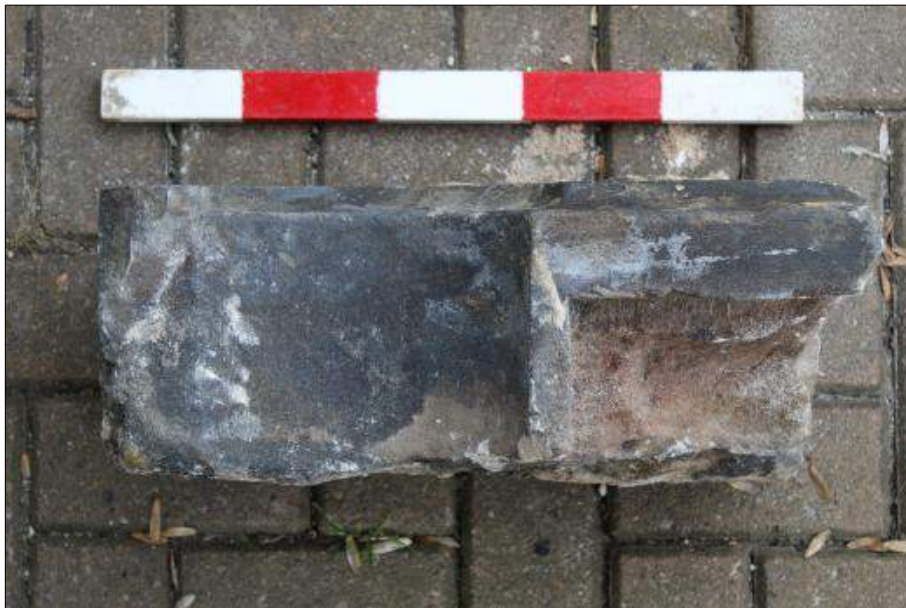
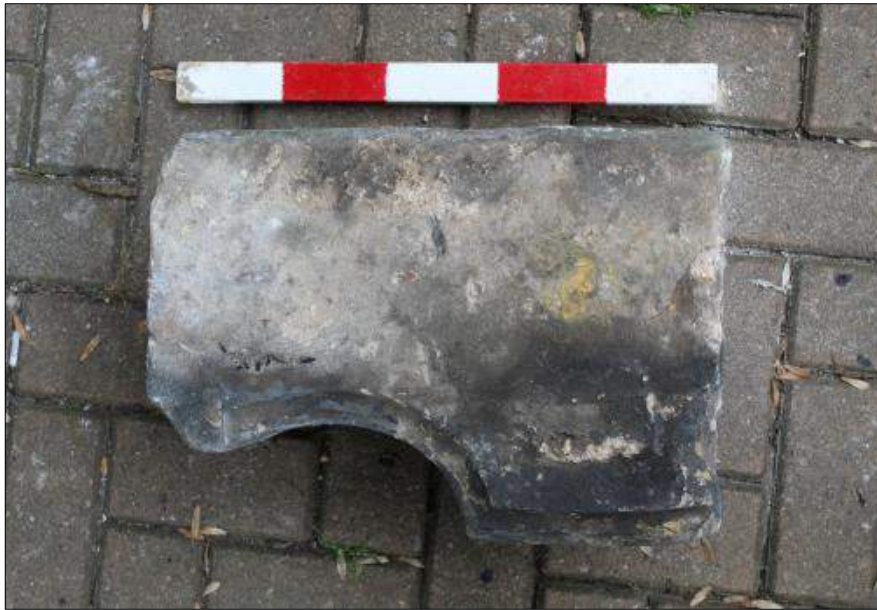
*Plate 13: Worked masonry built into wall 110, 0.5m scale*

- 7.21 A worked masonry fragment possibly representing part of a memorial, or alternatively an architectural fragment, was built into the fabric of wall 110 (Plate 13).

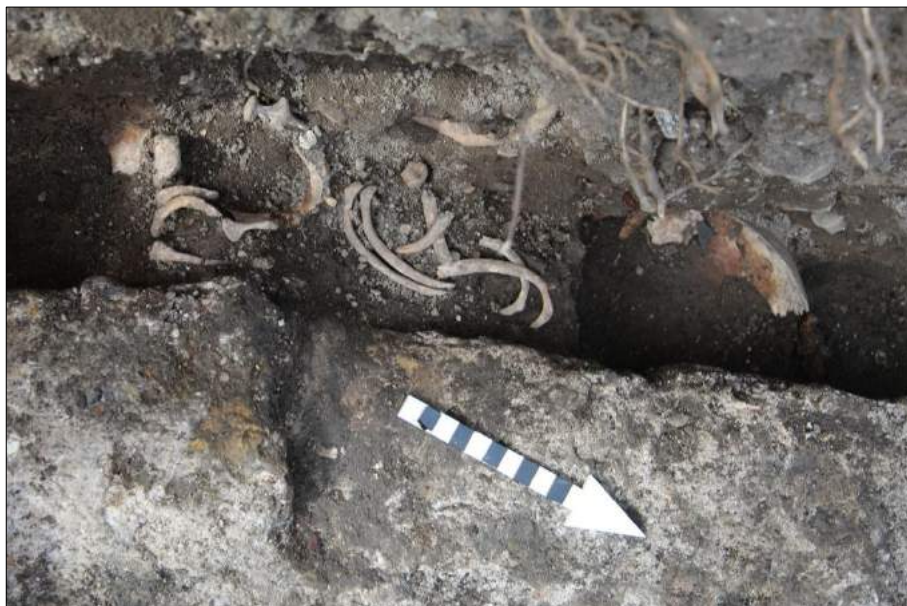
*Plate 14: Infant burial SK 113 adjacent to wall 110, 0.10m scale*

- 7.23 A single articulated, though disturbed, infant burial (SK 113) was recorded immediately to the southwest of the foundation of wall 110 (Plate 14). As far as could be ascertained, the burial was aligned roughly southeast to northwest, following the alignment of the wall, with the head to the southeast. A small pit [116], containing two fills, 114 and 115, and 0.65m deep by 1.01m wide, was recorded in section immediately adjacent to and above the burial (Figure 4).

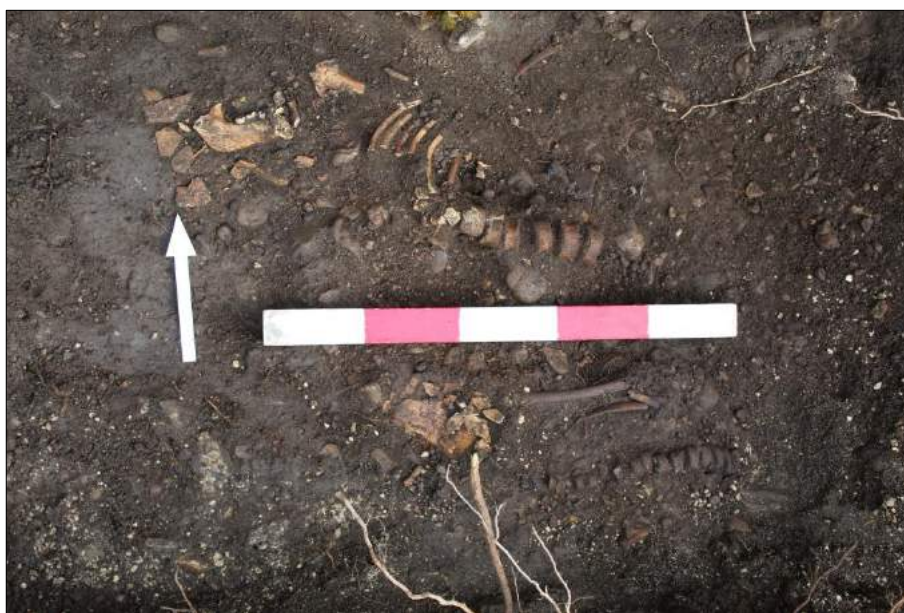
*Plate 15: Burials SK 134 (above scale) and SK 135 (below scale), 0.5m scale*

- 7.26 The furthest southwest of the recorded burials, c.7.5m northeast of the gatepost of the church entrance, comprised two individuals. The southernmost burial, SK 135, was that of an infant and was supine (on their back) and extended. Skull fragments, ribs, vertebrae and parts of both arms were observed (Plate 15).

- 7.27 To the north of SK 135, SK 134 was the supine, extended burial of a juvenile, aligned east-west, with the head to the west. Fragments of skull, ribs and vertebrae and part of the left scapula were recorded.
- 7.28 Approximately 3.5m to the northeast of these two burials was another group of burials, comprising at least four articulated inhumations, along with a skull that may represent a fifth intact burial that lay almost completely outside of the excavated area. From south to north the burials were recorded as SK 141, SK 142, SK 145, SK 144 and SK 143.
- 7.29 SK 141, comprised a supine, extended adult inhumation, represented by the skull, mandible, left humerus, clavicle and scapula, with some vertebrae and left ribs. There was

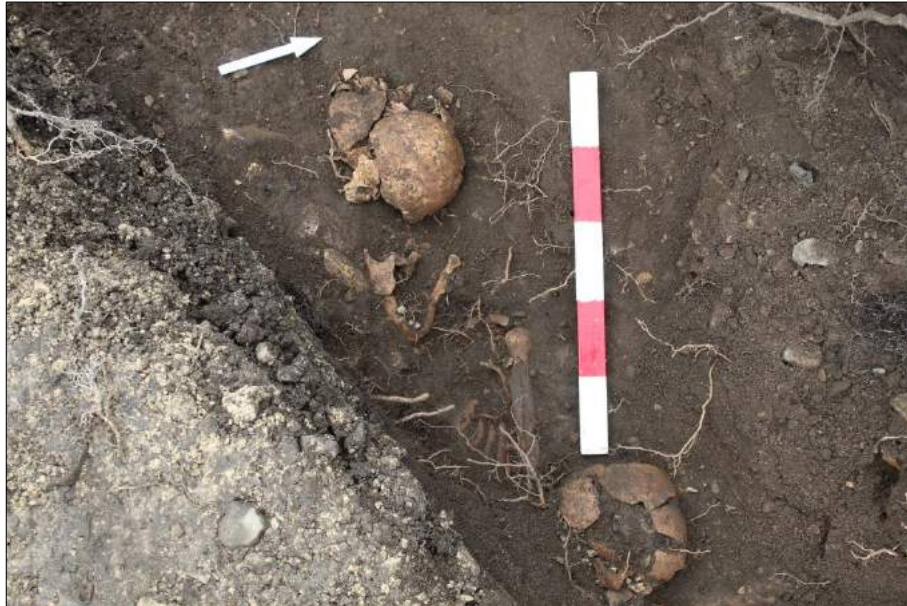
*Plate 16: Burials SK 141 (to left of scale) and SK 142 (below scale), 0.5m scale*

considerable ante-mortem tooth loss from the mandible, suggesting the individual was of relatively advanced age at death (Plate 16).

- 7.30 Immediately to the north of the left arm of SK 141, SK 142 was the skull and mandible of an adult. As both were present it was assumed that SK 142 represents an articulated burial, although the majority lay outside of the excavated area.

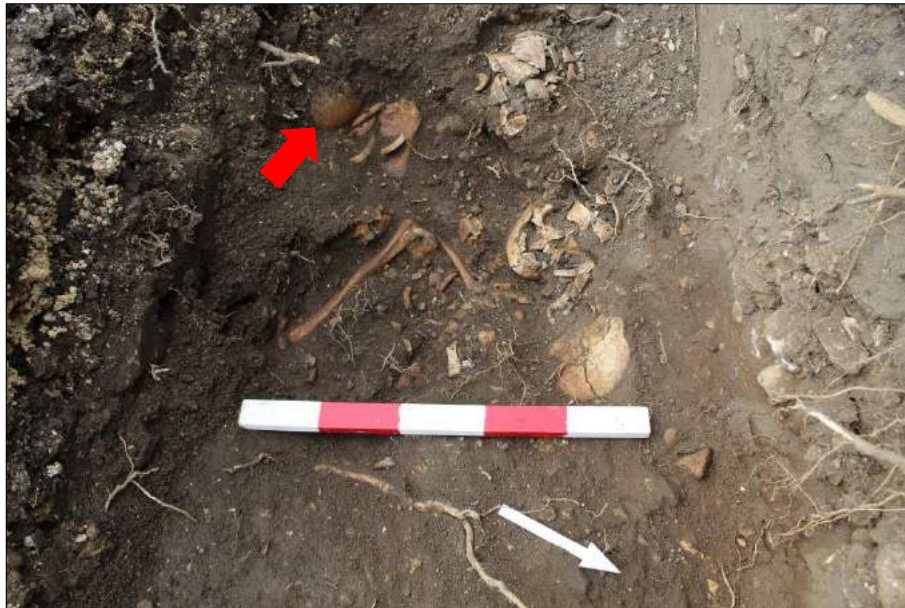
*Plate 17: Burials SK 143 (closest to scale), SK 144 and SK 145 (indicated by red arrow), facing southwest, 0.5m scale*

- 7.31 To the north of this pair of burials, SK 145 was a partially visible subadult skull that is likely to represent another articulated burial. To the north of SK 145, SK 144 was an extended, supine adult burial comprising a damaged skull, some ribs and vertebrae and the right scapula. The skull of SK 145 was located immediately to the south of the scapula of SK 144, which was truncated by a later burial, SK 143, to the north. This burial comprised a supine, extended adult inhumation, represented by the skull, mandible, left humerus, clavicle and scapula, some vertebrae and both left and right ribs. A single tooth from the mandible had been lost ante-mortem (Plate 17).

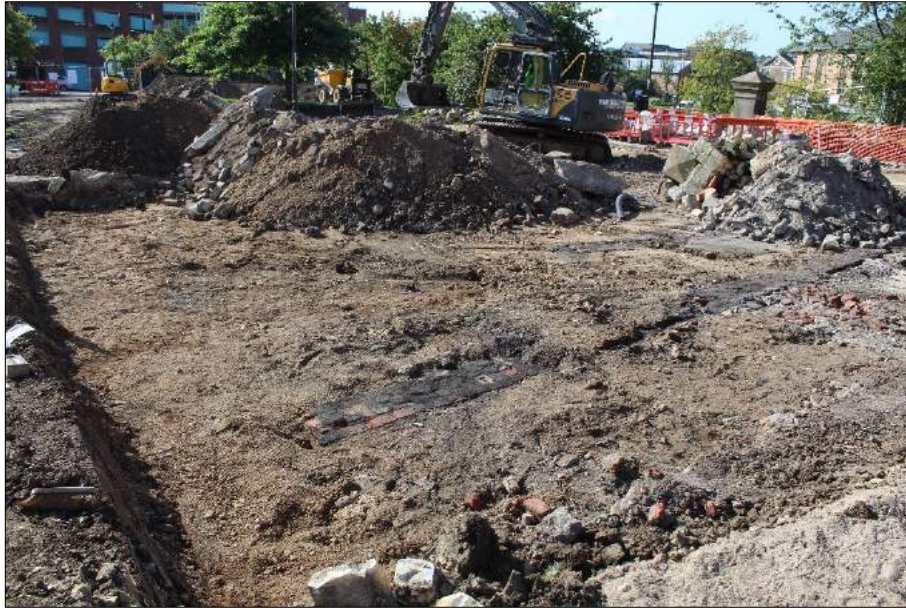
*Plate 18: Proposed amphitheatre area during stripping, looking southwest*

- 7.34 Two sections of northeast to southwest aligned wall were recorded in the area to the south of the church in the area of the proposed 'amphitheatre'. The wall lay immediately beneath a layer of demolition rubble >0.49m thick, 122, which was sealed by 0.20m of topsoil, 121 and paving, 120 (Plate 18).

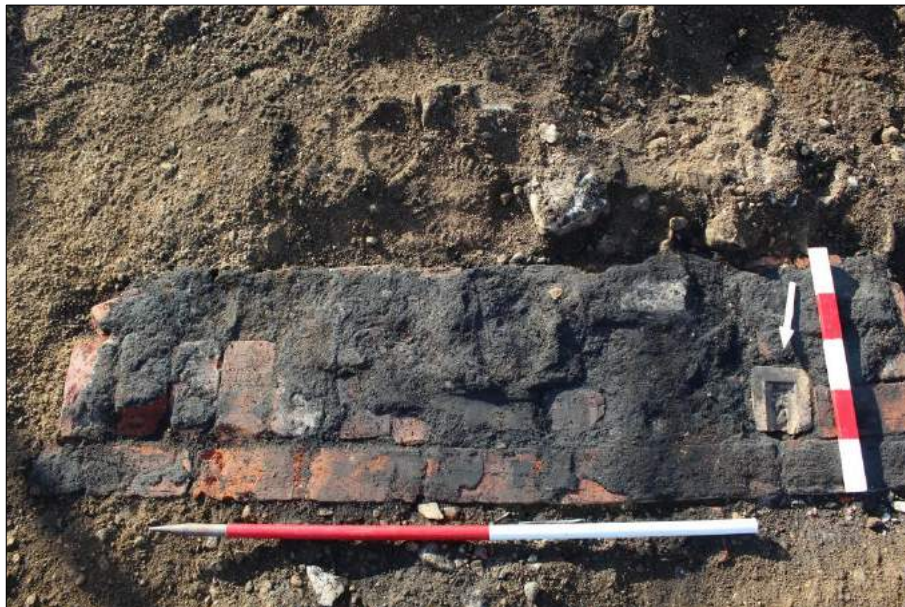
*Plate 19: Section of wall foundation 118 showing broken firebrick (arrowed), facing south, 1m and 0.5m scales*

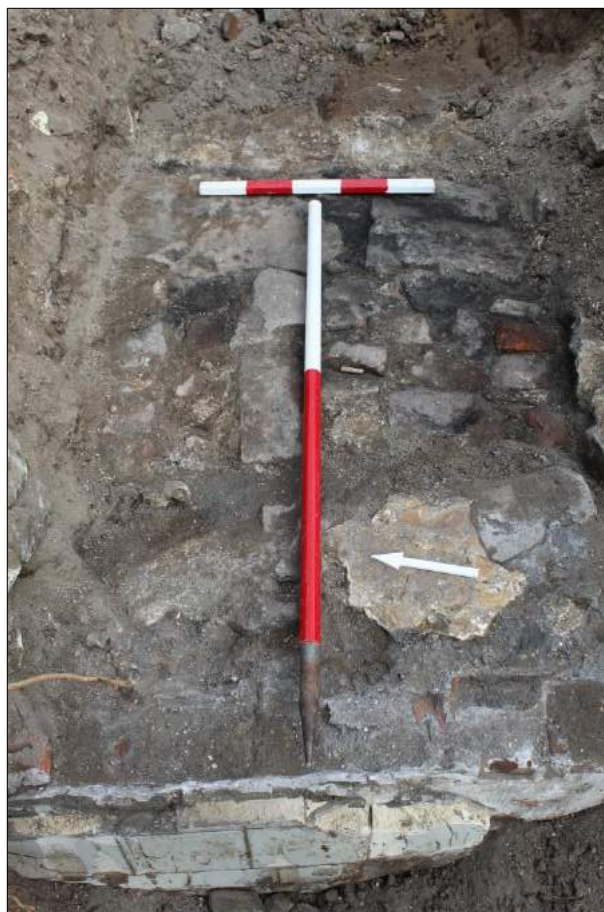
*Plate 20: Wall 123, floor surface 125 and wall 126, facing northeast, 1m and 0.5m scales*

- 7.37 The southwest wall, 123, comprised mixed brick and sandstone masonry bonded with hard mid grey sandy mortar, and faced on the southwestern side with white glazed fireclay tiles, which probably represent a late alteration to the wall. It was 0.51m wide and over 0.54m in height and was abutted to the northeast by a floor surface 125, comprising mixed hand-pressed unfrogged red brick and limestone flags. The floor surface measured only 0.92m northeast-southwest, where it abutted a 0.17m wide brick wall. The floor surface was overlain by 112, a compact deposit of coal fines and ash, 124, suggesting that it was the base of a coal-house attached to the rear of the building (Plate 20). The mid reddish brown slight clay natural geology was encountered at the base of the footing.
